BACK LANE WALL (Minute 173/01)

1 SUMMARY

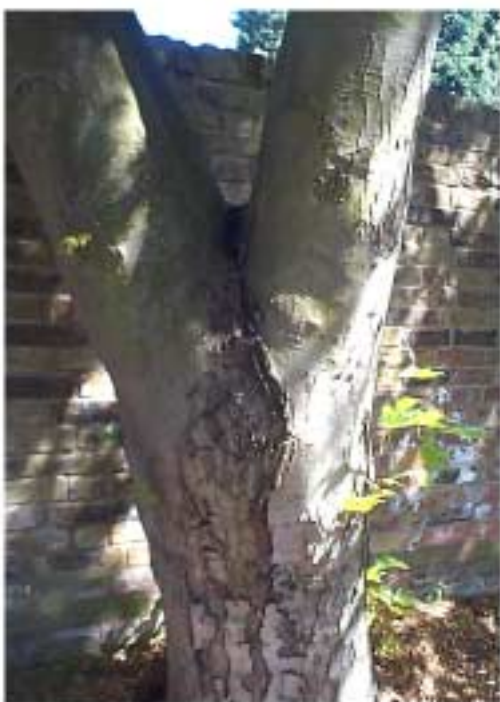
- 3.1 There are a number of options that can be considered in dealing with the damage to the wall each having a cost attached;
- 3.1.1 To rebuild the damaged section of wall after removing the tree and offending roots. This option can be considered because the tree has a forked trunk which is showing signs of deterioration at the fork due to water damage. Photographs of the tree condition and damage to the wall are included in Appendix A. This option would include replacing the tree with a suitable alternative. The estimate for this option is £1000.

Damage to Tree at fork in Trunk

2 That members agree to the removal of the offending tree and rebuilding of the original wall

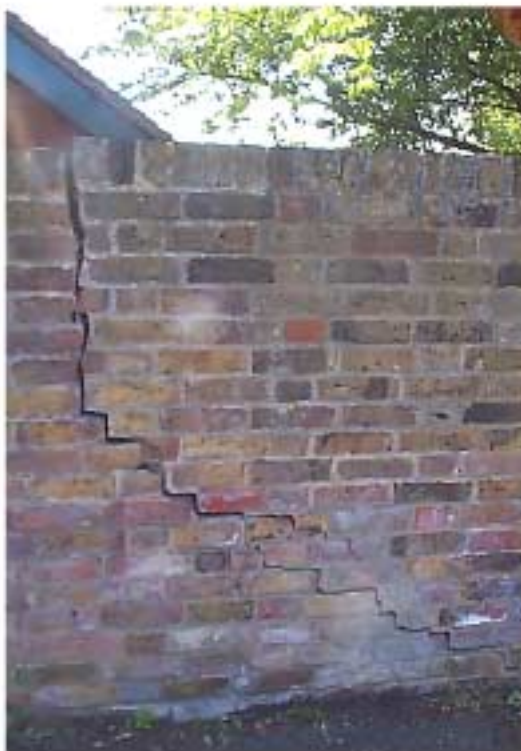
- 2.1 The original report sought permission to replace a section of the wall damaged by tree roots with a section of railings in order to provide a cost effective long term solution to the problem.
- 2.2 Some Members expressed concern about the need to remove the tree adjacent and causing the damage although a report on the condition of the tree was included indicating that the tree was of limited life expectancy.
- 2.3 The wall at this location has moved and been displaced from it's original line by approximately 25millimetres (mm), and in height by approximately 50 mm.

Displaced Wall

- 3.1.2 To demolish the damaged section and replace with railings as originally proposed. Although the sense of enclosure of the CAB car Park is partially lost this does provide the option to retain the tree. However the arboricultural report does state that the tree has a limited life due to the water damage and eventually will need to be replaced. The estimate for this option is £1000.

-
- 3.1.3 To demolish the wall and bridge the roots of the tree with a reinforced concrete beam on new foundations away from the tree roots. This option also retains the tree, but depending on the exact location of the roots would not enhance the appearance of the wall. The estimate for this option is £3000.

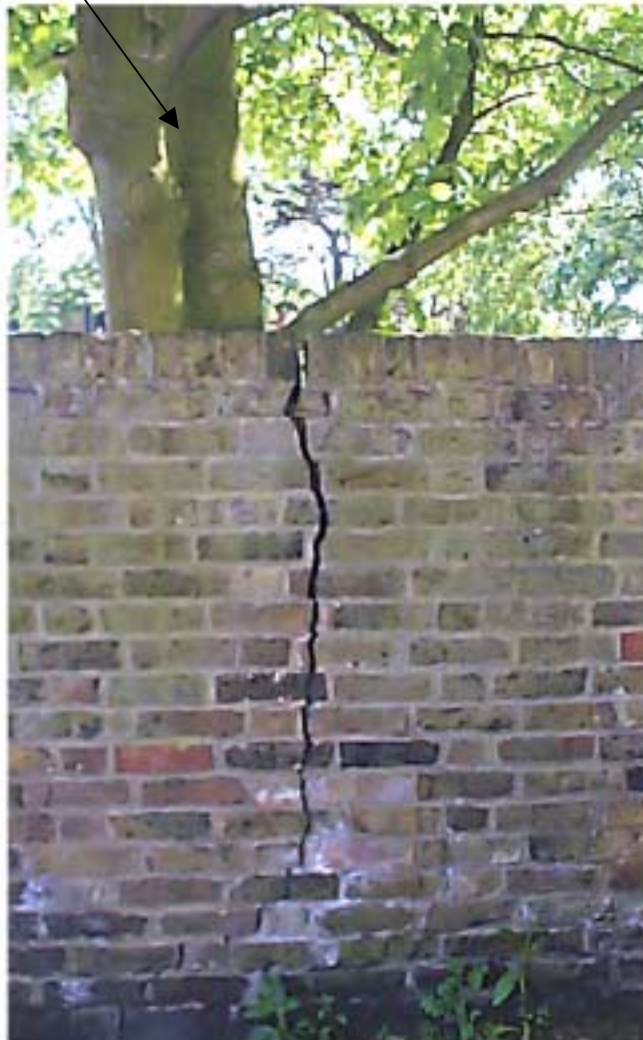
- 3.2 There is another crack in the wall also due to tree root damage, photographs in Appendix B, but at this stage there is no sideways movement and little horizontal movement of the wall. This can therefore be repaired by stitching the wall with new brickwork. The tree at this location is self seeded and ought be removed and replaced by a more suitable species to prevent further long term damage to the wall.

Remove this tree

Second Crack – Wall lifted but repairable by “Stitching” with new bricks
