**REPORT TO THE MEETING OF THE EXECUTIVE 19 JANUARY 2011****PORTFOLIO: FINANCE AND RESOURCES****REPORT FROM HEAD OF LEGAL, ESTATES AND MEMBER SERVICES****SUBJECT: REPAIRS TO THE REAR ACCESS STEPS AT THE CIVIC SUITE, RAYLEIGH AND THE CREATION OF AN ACCESS RAMP****1 DECISION BEING RECOMMENDED**

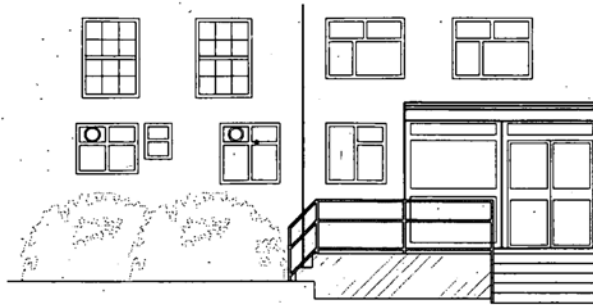
EXISTING SOUTH ELEVATION

- 2.1 The structure at the rear of the Civic Suite, forming the rear access steps, has failed due to ground movement. A structural engineer's inspection confirmed that the structure was beyond repair and required demolition and rebuilding.
- 2.2 Norfolk Property Services (NPS) were commissioned to design, tender and project manage the works to bring the rear access back into good order. This work was placed as part of the Brentwood Framework Agreement for a fee of £2,950 to include the Construction Design Management legal requirements for the works.
- 2.3 The demolition and construction works were tendered with five companies responding to the tender with prices ranging £21,960 (M T Build) to £33,811. M T Build are considered a competent contractor for this type of work and so NPS have recommended that they are appointed. An indicative copy of the existing and proposed plan is appended.

- 1.1 To proceed with the refurbishment of the steps at the rear of the Civic Suite and the creation of an access ramp to provide both disabled access and the loading of stores.
