Rochford District Council

ROCHFORD CONSERVATION AREA APPRAISAL AND MANAGEMENT PLAN

April 2006

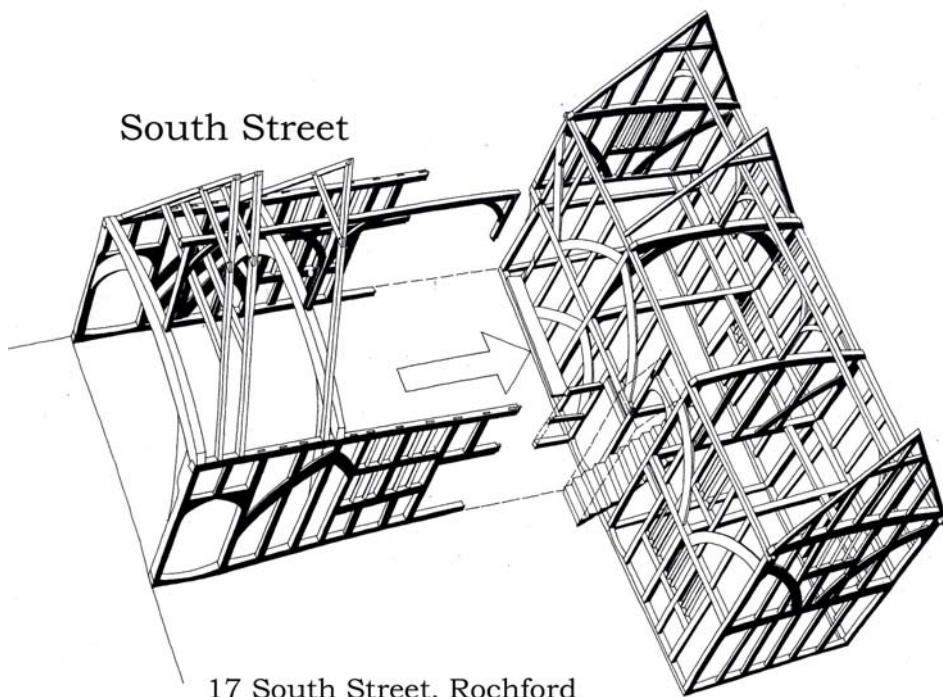
Fig. 3 The timber frame of 17 South Street.

- 5.8 The oldest house in the town is no. 17 South Street and dates from the 14th century (*Fig. 3*). It is an H-plan house comprising a hall and two cross-wings. Located half way down the street, it suggests that this part of the town may have grown rapidly, though its position on the way to the river crossing may simply reflect the importance of this thoroughfare. Early medieval pottery has been found in East Street (Eddy 1984-85) where there is also an old house, Kings Hill, believed to be of comparable date to 17 South Street.

- 9.31 **No. 17**, listed grade II*, 14th-century hall and cross-wing to north, later cross-wing to south, classic H-plan appearance (*Fig. 3*). Rendered timber frame, black painted joinery, though one door in the façade is unaccountably painted brown. Known as the Old House, this building was carefully restored by Rochford District Council in 1982-83 and is now used as offices by the local authority (English 1984). Excavations carried out at the time of the restoration remain unpublished.

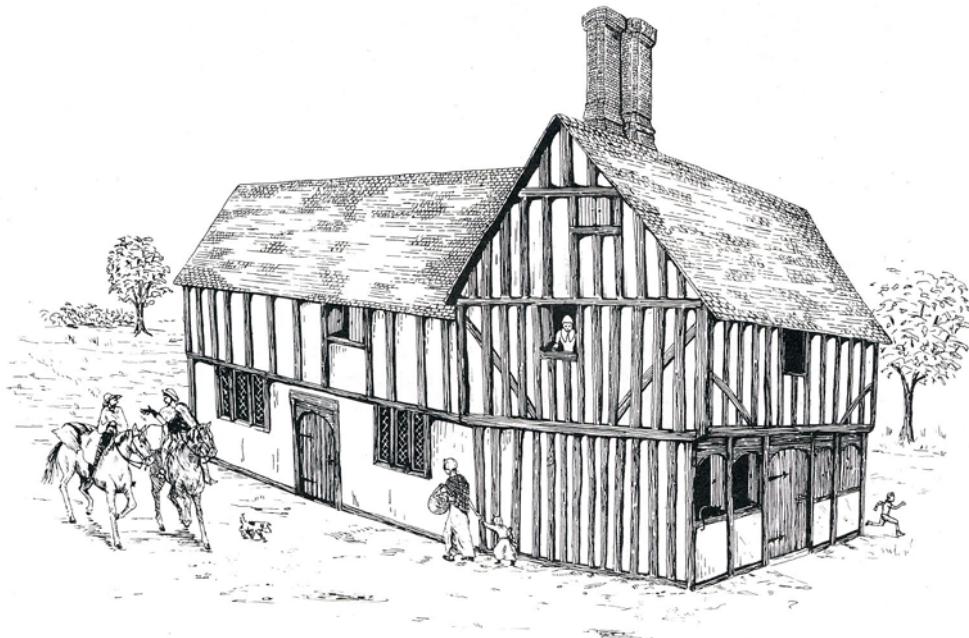
A reconstructed view of the timber-framed buildings which exist behind the brick cladding at Horners Corner

Fig. 4 Reconstruction of the timber-framed buildings at Horners Corner as they might have appeared in the 17th century.

- 5.9 The market place is on the west side of the cross-roads and is still used on Tuesdays. It was formerly much larger. The triangle of land with buildings tightly grouped together on small plots at the junction of North Street and East Street is characteristic of infilled market-places (cf. Chelmsford and Rayleigh). Evidence for the process of infill has been found in excavation at the former butcher's shop known as Horner's Corner at the southernmost tip of the triangle. At a depth of over 1.5m below present ground level, gravel surfaces which seem to relate to earlier phases of the market-place were found. A succession of small and relatively short-lived timber buildings erected on these surfaces must represent stalls erected by traders seeking a more permanent pitch in the market-place. This process culminated in the construction in the 16th century of the timber-framed building which was found behind the brick façade of Horners Corner. This had a shop front facing on to South Street and was jettied on both its north and south sides (*Fig. 4*).

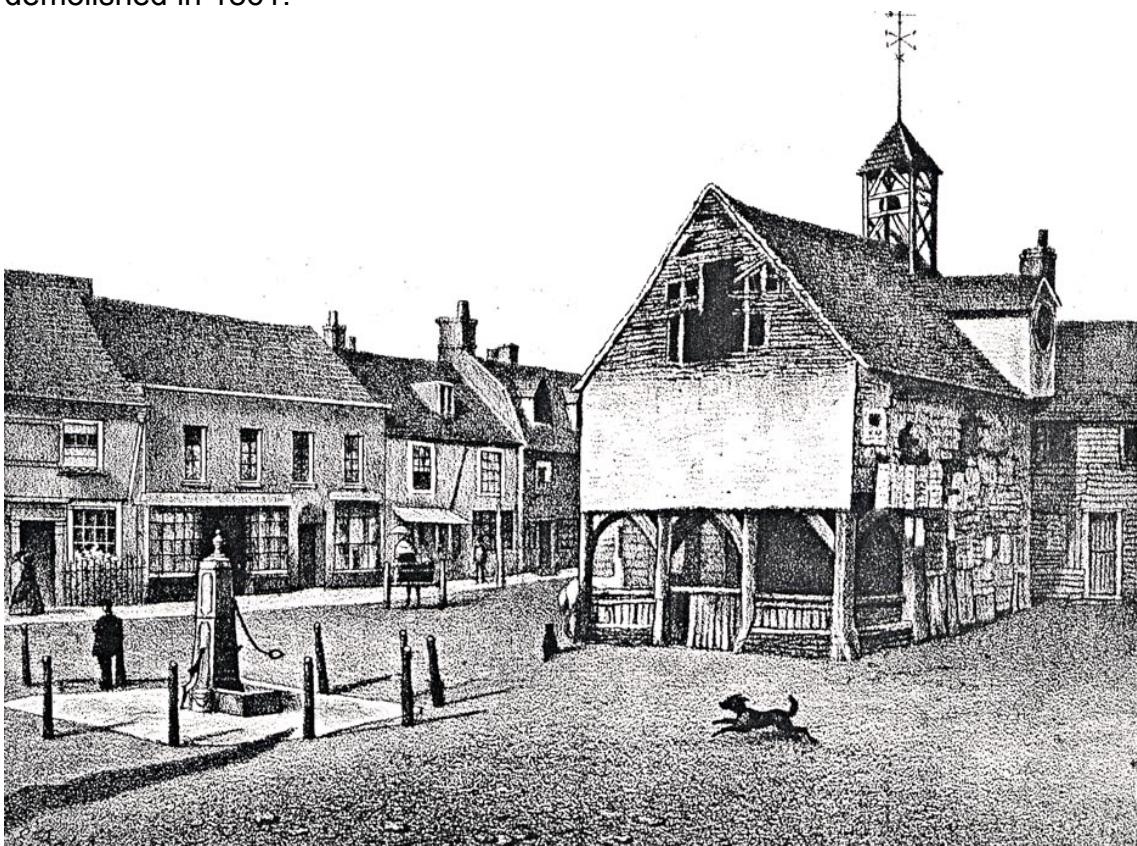
Fig. 5 The Market House in Market Square, demolished in 1861.

- 5.12 It can be argued that the market extended further still, occupying a large open area on both sides of West Street. This street presents a typical medieval street pattern, with a back lane running behind and parallel to it. The short depth of the plots suggest that they are infill of a regular row of stalls on one side of a wide market street, comparable, for instance, to Rayleigh High Street. Such rows are well preserved at Saffron Walden and Bury St. Edmunds. No late medieval houses survive intact in West Street, but a fragment of a 15th- or 16th-century house has been identified incorporated in no. 41.
- 5.13 A market house formerly stood in the Market Square, a building of the type open at the ground floor and with office accommodation above, as at Thaxted or Horndon-on-the-Hill (*Fig. 5*). It is said to have been built in 1707 and was demolished in 1861.

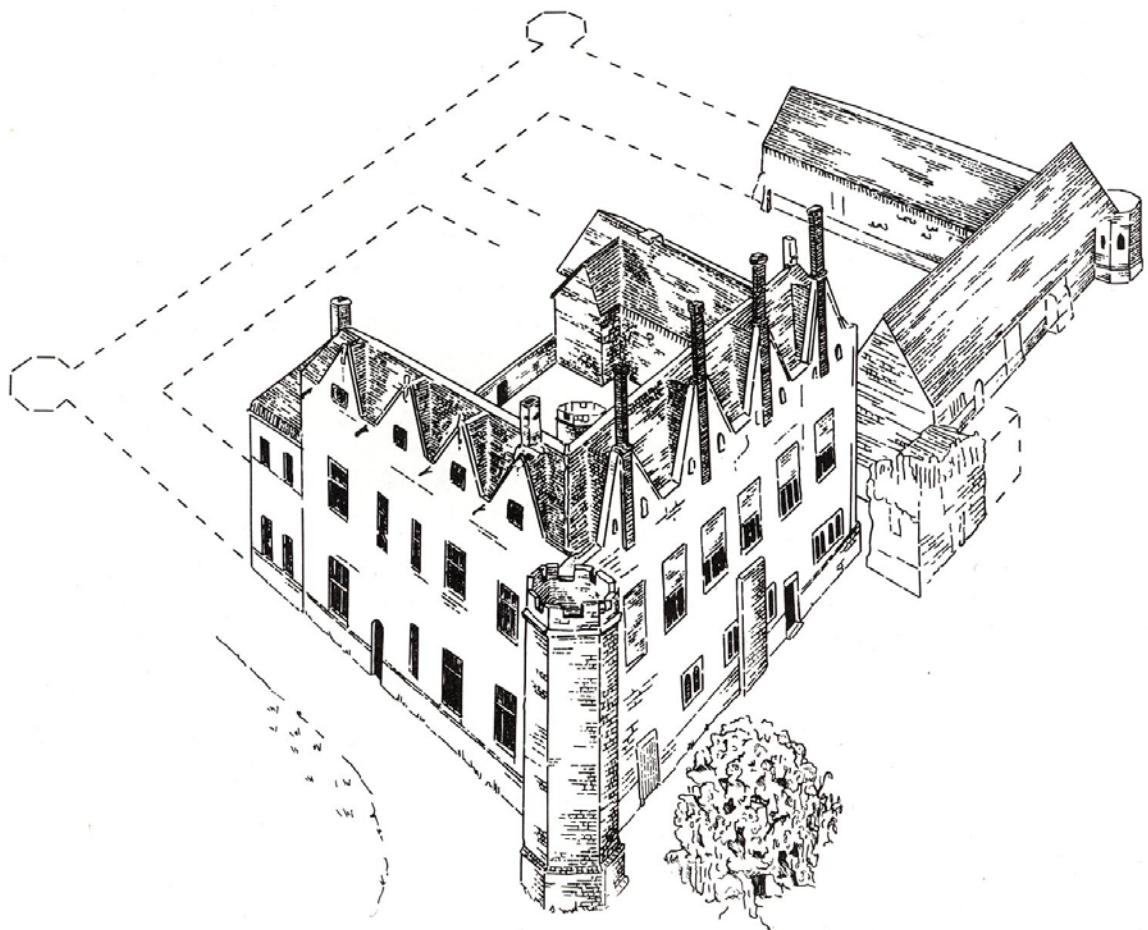
A reconstructed view of Rochford Hall (after Norman Barnes)

Fig. 6 Rochford Hall, before the barns were converted to residential use. The original extent of the mansion is shown dashed

- 5.16 Sir Henry Carey, Mary's son by her first marriage, sold the manor with other property to Richard lord Rich in 1550 for £2000. The lands acquired by Rich included 2000 acres of arable, 500 acres of meadow, 3000 acres of pasture, 1000 acres of wood, and 2000 acres of furze and heath. Richard lord Rich remodelled the manor house as a vast Tudor mansion, part of which survives today (Fig. 6).

- 9.4 When it was first built, by Richard lord Rich in the 1550s, **Rochford Hall** was probably the largest mansion in Essex. It was about 200 feet square with octagonal corner towers, and rows of gables, a somewhat precocious feature at this period, separated in the middle of each side by large square projections resembling towers. Until recently, it has been a poorly understood building, and its place in the development of Tudor architecture not really assessed. Today it is reduced to an E-shaped plan, less than half its former size (*Fig. 6*). Until the 1970s, the eastern part was the Rochford Hundred Golf Club and a farmhouse, whilst the western part was used as barns, which were eventually abandoned and became increasingly derelict. In the 1980s, the barns were converted to dwellings, a moat dug out, and improvements effected to the landscape of the immediate vicinity (Clark 1990). The Hall is listed grade 1. The western part (i.e. the former barns) is a scheduled ancient monument. The scheduling takes precedence over the listing. For this reason, the conversion was carried out free of building control. It is curious that this part of the building remains scheduled after the conversion as residential buildings are not normally scheduled.

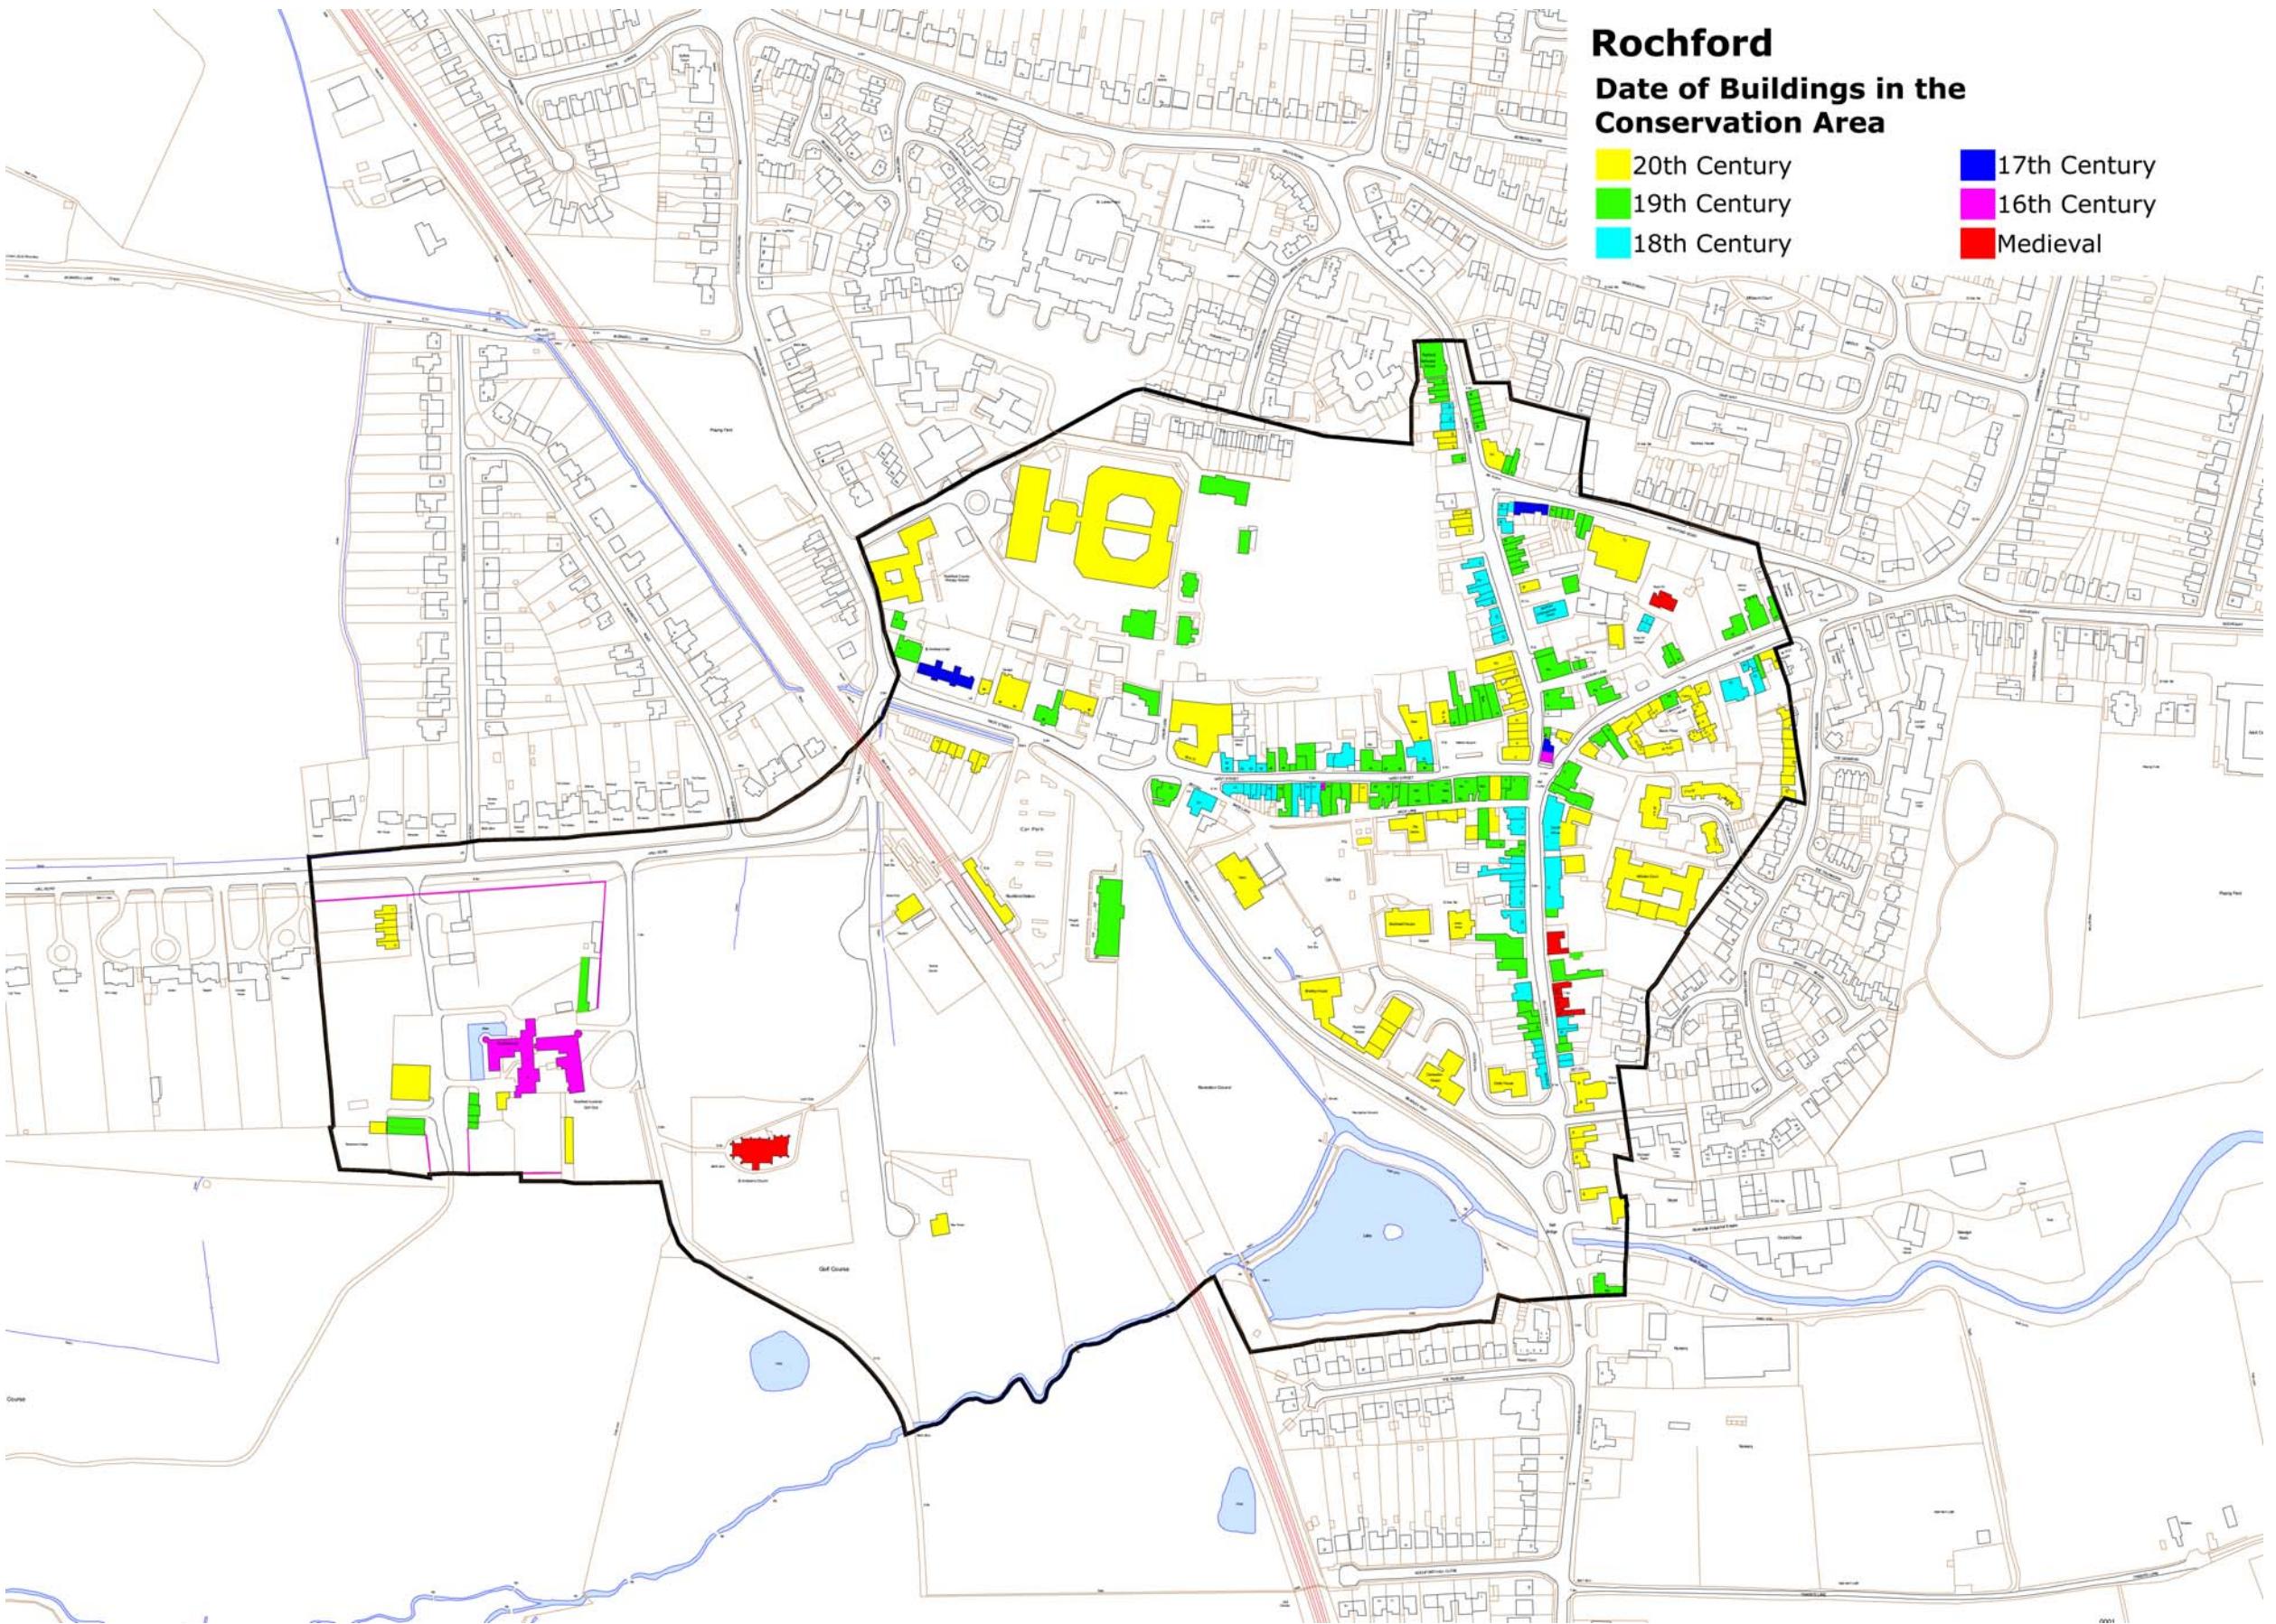
Fig. 8 Date of construction of buildings in the conservation area.

- 5.18 Rochford seems to have prospered in the 18th and 19th centuries inasmuch as buildings of that period comprise a significant part of the town's housing stock (*Fig. 8*), representing about 80% of the listed buildings. It was the principal town of the area before the rise of Southend, and access to the coast meant it was more strategically situated than Rayleigh. A wide range of trades and industries were carried on, but there seem to have no particular specialisation like weaving which in other Essex towns could bring prosperity but also economic collapse in hard times.

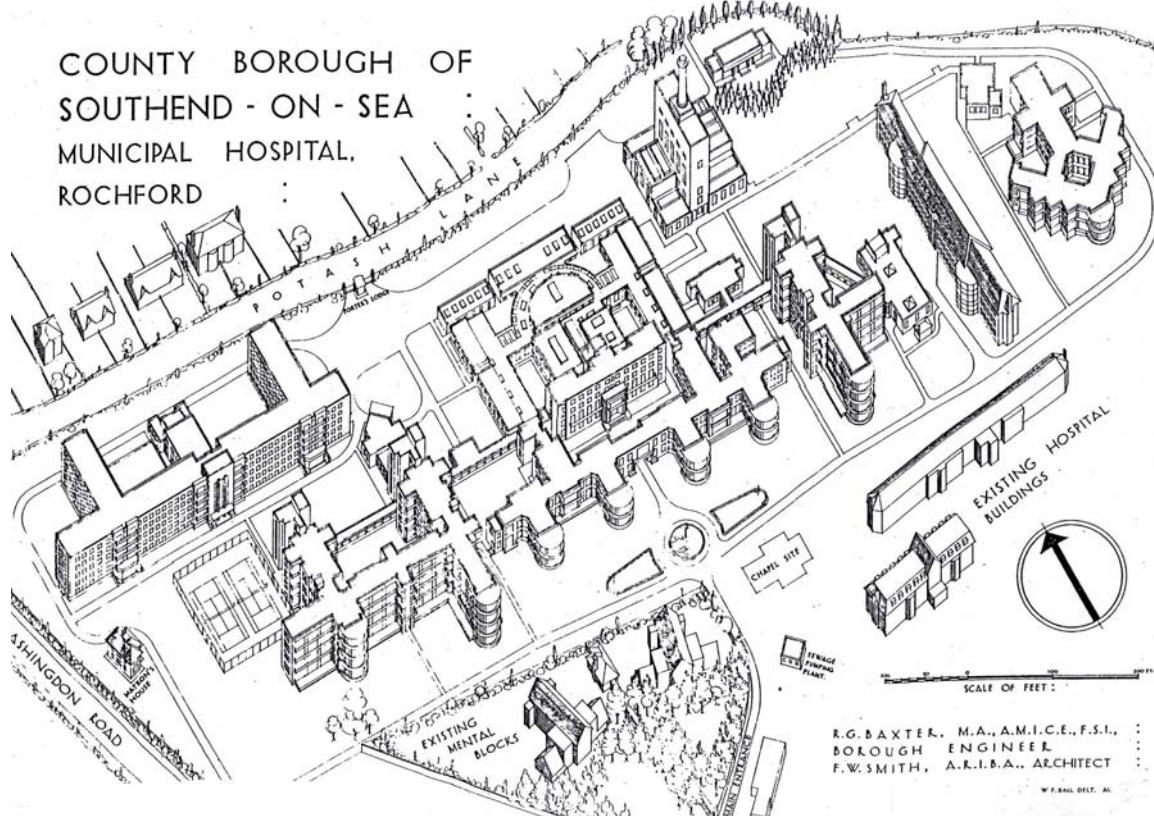
Fig. 9 Architect's drawing of the Hospital Extension Scheme buildings of the 1930s.

- 5.22 The Hospital Extension Scheme buildings followed the most modern and advanced criteria for hospital design, and are in the Modern Movement or International style (*Fig. 9*). They are built of yellow London stock bricks, with blue engineering brick plinth details. The walls are solid brick 340mm thick. The roofs are flat, of reinforced concrete. Windows are of galvanised metal in a hardwood frame. The principal surviving buildings (the nurses' lodging has been demolished and replaced with housing), the Main Block, the Johnson Isolation Block, and the boiler house, lie outside the conservation area but are now listed. They have been converted to residential use. The boiler house, a narrow rectangular five-storey building with a chimney, is a major landmark which can be seen from a long way outside the town.

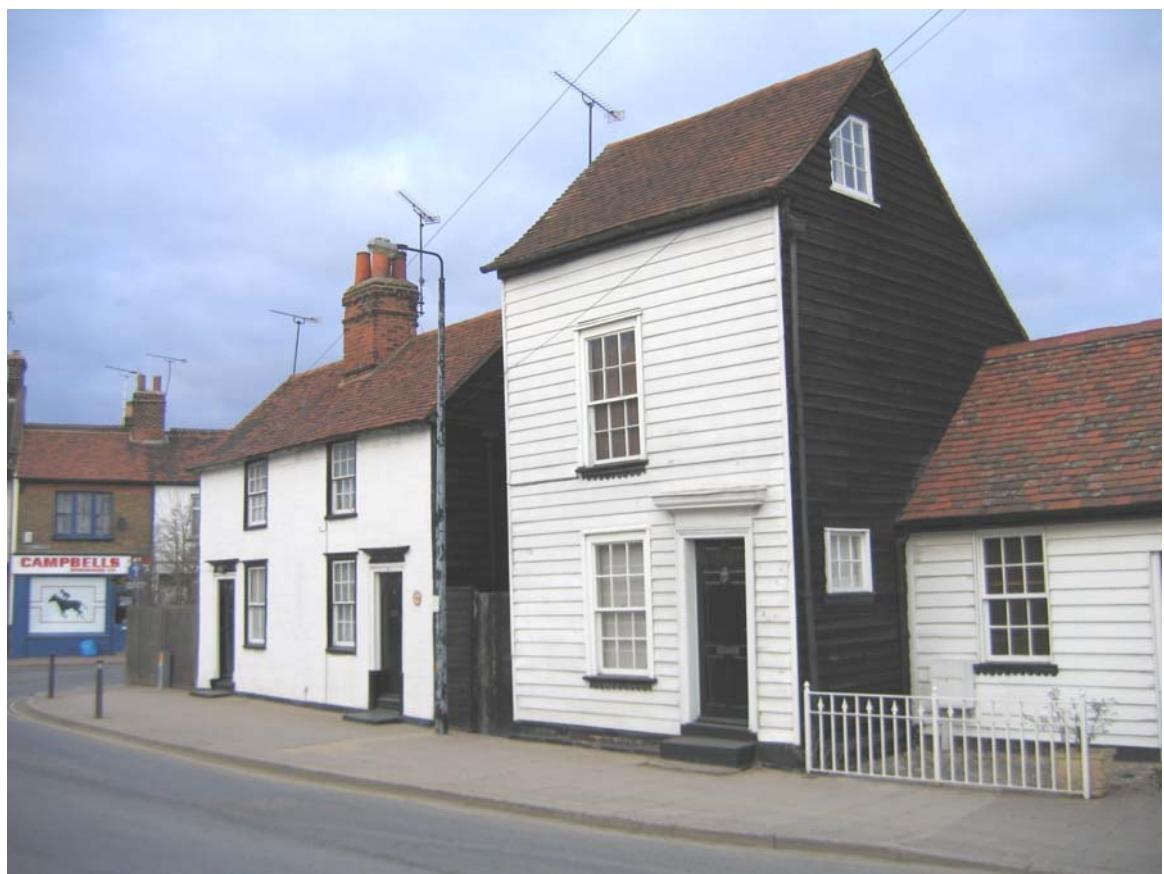
Fig. 10 North Street, no. 36, typical weatherboarding and black and white painted joinery. Nos 38-40 have a rendered or Roman cement painted façade, lined out in imitation of masonry.

- 6.1 Older buildings in the town centre are timber-framed. The fabric of 17 South Street incorporates quite a lot of elm, something which may reflect a shortage of oak from an early date. Today there is no authentic exposed framing: the frames are mostly concealed by weatherboard, render or brickwork.
- 6.2 Weatherboarding was a cladding material much used on timber-framed buildings in South Essex and indeed London from the 18th century. Rochford is outstanding in preserving large numbers of old weatherboarded buildings. Characteristically the façade is painted white and the sides black, with black and white joinery (*Fig. 10*). In the late 18th and 19th centuries, houses were improved by cladding in render, often lined out in imitation of ashlar stonework, or brick. This work was often confined to the front elevation, and weatherboard can be found on the sides (*Fig. 10*).

- 1.25 **No. 36**, 18th- or 19th-century, listed grade II, tall narrow weatherboarded house with single storey weatherboarded garage and outbuilding on south side, rear gambrel roofed extension. Weatherboard, white to front, black to sides. Simply moulded door case (*Fig. 10*).

- 1.26 **Nos 38-40**, grade II listed, 18th- or 19th-century, pair of semi-detached houses, front rendered and lined out, white painted, black weatherboarded flank, central chimney stack, rear outshot (*Fig. 10*).

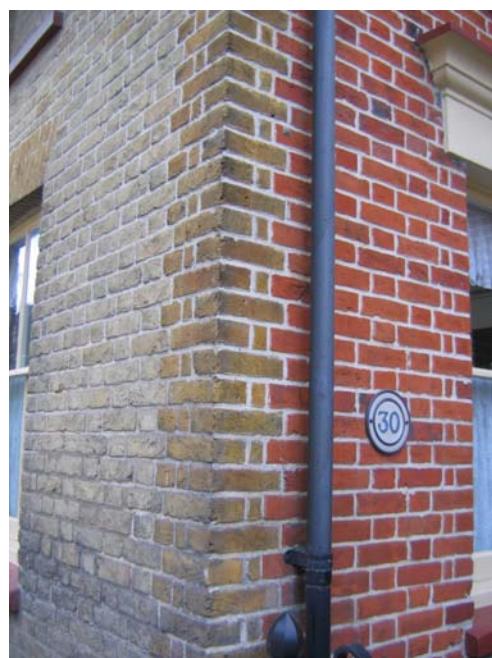
Fig. 11 Angle of nos 30-32 South Street. White bricks were used for the façade, with stocks for quoins and window lintels, and red bricks in the side.

- 6.6 The use of white bricks was limited, confined for the most part to the facades of municipal buildings. They do, however, occur on the front of a terrace (nos. 32-36) in South Street, where stock bricks are used for quoining. Stocks seem not to have been considered an inferior product as was often the case, perhaps because they were regarded as a local equivalent of white brick. Thus at no. 19 South Street, a three-storey house, the façade is of stocks and the sides of red brick. Stock bricks were used for the 1930s Modern Movement style buildings of the Hospital Extension Scheme.

- 9.50 **Nos 32-36**, row of three 19th-century houses, the right hand one probably incorporating an earlier building that belonged to the Sydenham House school. Gault brick facades, stock brick quoining, red brick sides. Sawtooth cornice at eaves. Sash windows with segmental heads. Since 1986, all the windows, except for those at no. 32, have been replaced in plastic, adversely affecting the appearance of what would otherwise be an attractive terrace. Shutters to windows of no. 36 not entirely appropriate.

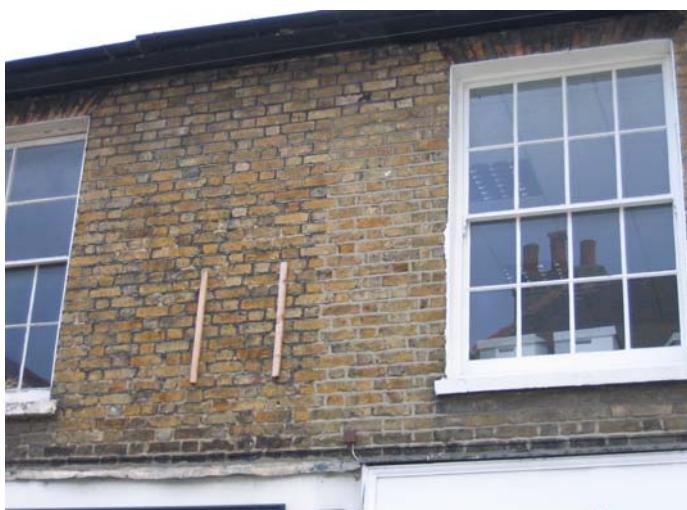
Fig 12 Nos 21-23 west Street. To the left, stock brickwork with tuck pointing. To the right, unnecessary repointing has had an adverse effect on the character of the brickwork.

6.5 These different types of bricks present a palette of materials which were used in a variety of different ways which are not always evident today. The older red brickwork was sometimes ruddled or treated with a red wash, and in the grander houses must in some cases have been jointed with tuck pointing. Traces of this seem only to survive at no. 22 South Street. Tuck pointing was also used in some stock brick buildings (e.g. no. 21 West Street, *Fig. 12*). Penny-struck pointing must once have been common, but can only be seen in a few instances today. Most of the brick buildings have been re-pointed in the second half of the 20th century, in many cases probably unnecessarily. This has led to an erosion of the character of the original brickwork (*Fig. 12*).

- 9.102 **Nos 21-23**, two storey, stock brick with sash windows at the first floor (*Fig. 12*), well preserved, but the ground floor a sad contrast, being rendered and white painted (*Fig. 44*), a series of shop fronts, the right hand one (mjj pharmacy locums) having been remodelled and set back behind the line of the façade with a large plate glass window.

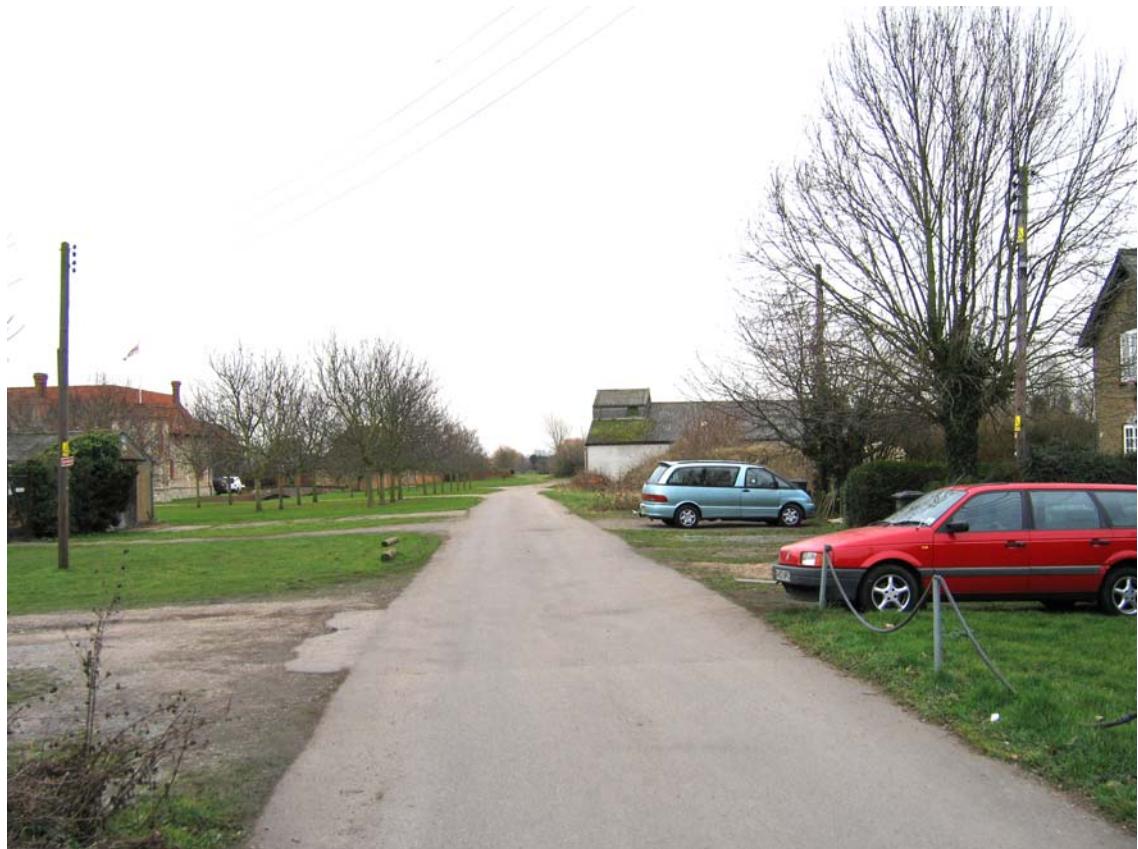
Fig. 16 Hall Road, access road to the Hall and grain store, an area that still preserves something of its agricultural character.

and a large cement rendered Dutch barn or grain store (*Fig. 16*). This area still has the aspect of a working farmyard, a valuable foil to the creeping suburbanisation of Hall Road and traditional setting to the Hall itself. An application made in the late 1980s to build a row of detached houses to the west of the Hall was rejected.

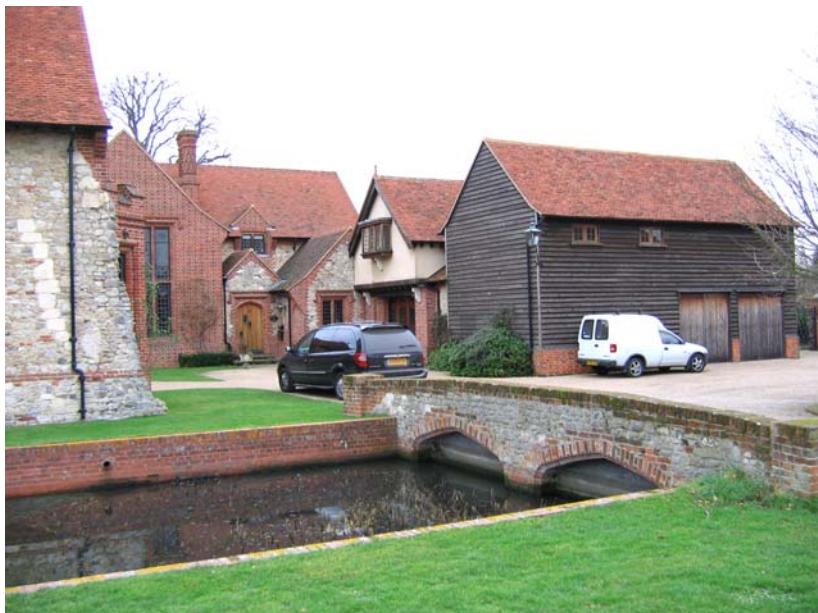
Fig. 17 Rochford Hall, a view of the residential conversion of the former barns area.

- 9.5 The conversion of the barns was done in an accurate mock Tudor style. It included small extensions, and also conversion of some farm buildings. Despite the density of the development, and the element of pastiche, 20 years on it looks good and has worn well (*Fig. 17*). The landscaping around it has also enhanced its setting.

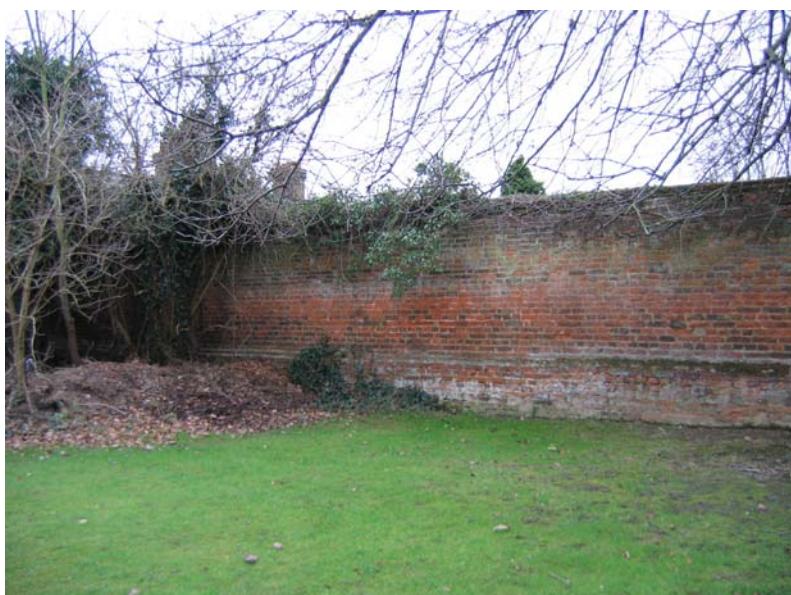
Fig. 18 Hall Road, one of the least overgrown parts of the Tudor boundary wall.

- 9.6 A grade II listed Tudor brick wall of the 16th or 17th century almost completely surrounds the site of the Hall. This has not been studied and the way the enclosures round the Hall were used is not understood. It is a major landscape feature of considerable historic interest, one that gives definition to the site of the Tudor mansion, but unfortunately not one that can really be appreciated from Hall Road as it is very overgrown by scrub and ivy. This should be partially cleared to avoid damage to the brickwork and to make it more visible (*Fig. 18*). The elevation to Hall Road is said to have diaperwork.

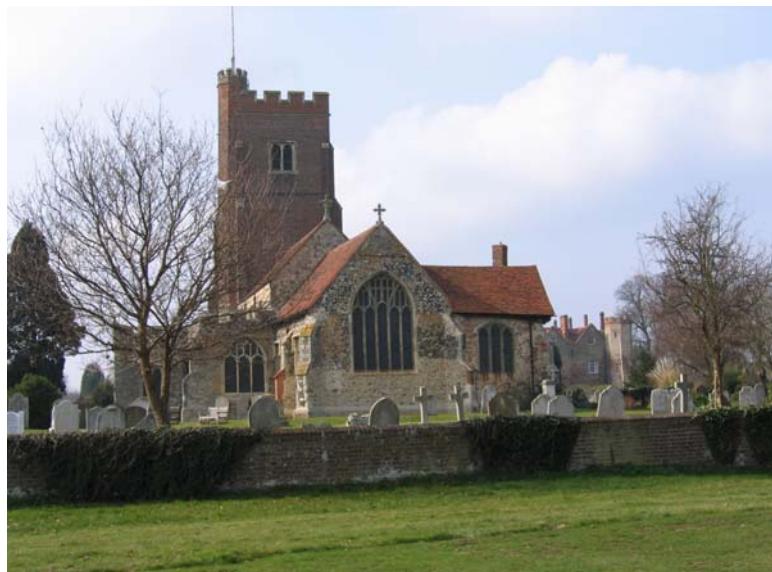
Fig. 19 St. Andrews church, the Hall in the background.

- 9.9 **St. Andrews church** is large with aisles, built mainly of Kentish ragstone, and predominantly 15th-century in appearance (RCHM 1923; *Fig 19*). Its most prominent feature is the magnificent late 15th-century brick tower with diaper work. Of interest is the vestry on the north side of the chancel which was probably built for a chantry priest in the 15th century. In 2005, two-thirds of the north aisle was partitioned off to provide toilet and kitchen facilities, and a meeting room, something which has helped to bring the building more into community use.

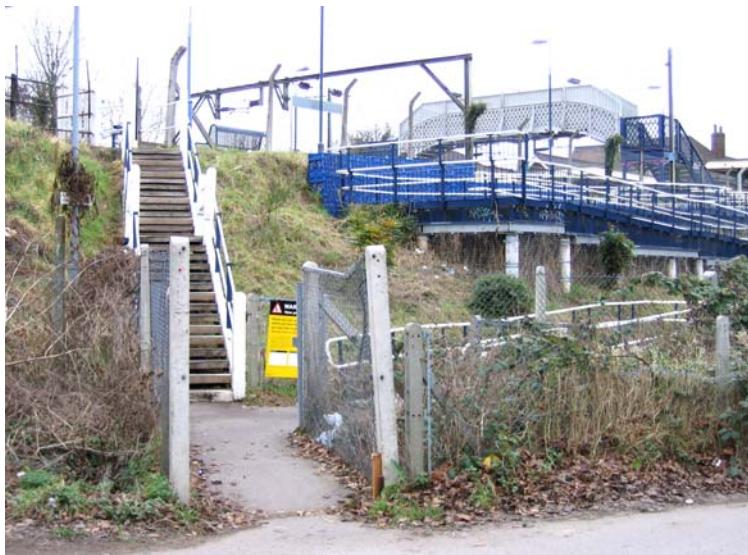
Fig. 20 Steps and ramp at the west access to Rochford station.

- 9.13 At the end of the cycle route, a flight of steps ascends the embankment to the west side of the station. The entrance to the steps is through a dilapidated chain link fence, whilst the posts and handrails are painted white and blue, making them excessively visible and an eyesore from a distance (*Fig. 20*). The steps are supplemented by a ramp which tacks up the side of the embankment. These too have unsightly handrails painted blue and white. These features make for an unsightly view at this end of Hall Road, not helped by the use of bright blue plastic reinforcing similar to milk crates used to revet the embankment at this point.

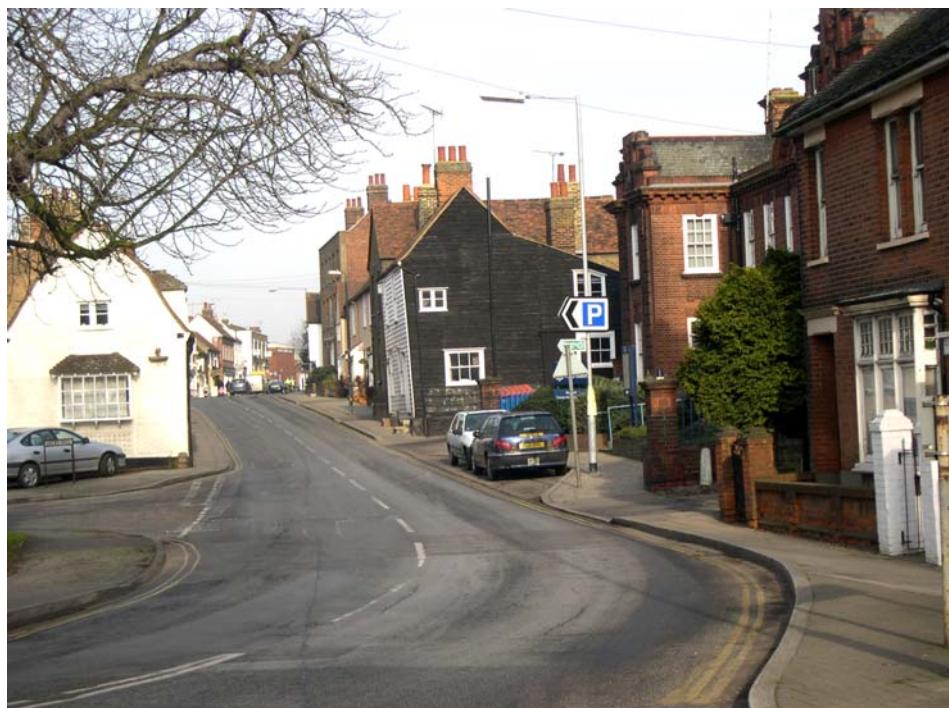
Fig. 21 View looking north up South Street. No. 47, Police Station and nos 39-41 on the right hand side.

9.16 South Street is the longest and best preserved street of period houses in the historic town centre. Its high visual quality is enhanced by the gentle rise up the side of the Roach valley from south to north, the slight curvature of the road to the east, and the gradual change in scale and materials from the cottages at the south end to the brick buildings further down it (*Fig. 21*). A street enhancement scheme was carried out in about 1994. The pavements have been refurbished with small rectangular concrete slabs with a textured finish and stone kerbs. Tegula is used for driveways and parking bays. The pavements are narrow, especially on the west side. Unlike the Market Square, South Street has not been provided with conservation-type lamp standards. The street lamps are not particularly conspicuous and some are fixed to buildings. However, they have been painted black over the galvanised finish, and this paintwork is now peeling and unsightly.

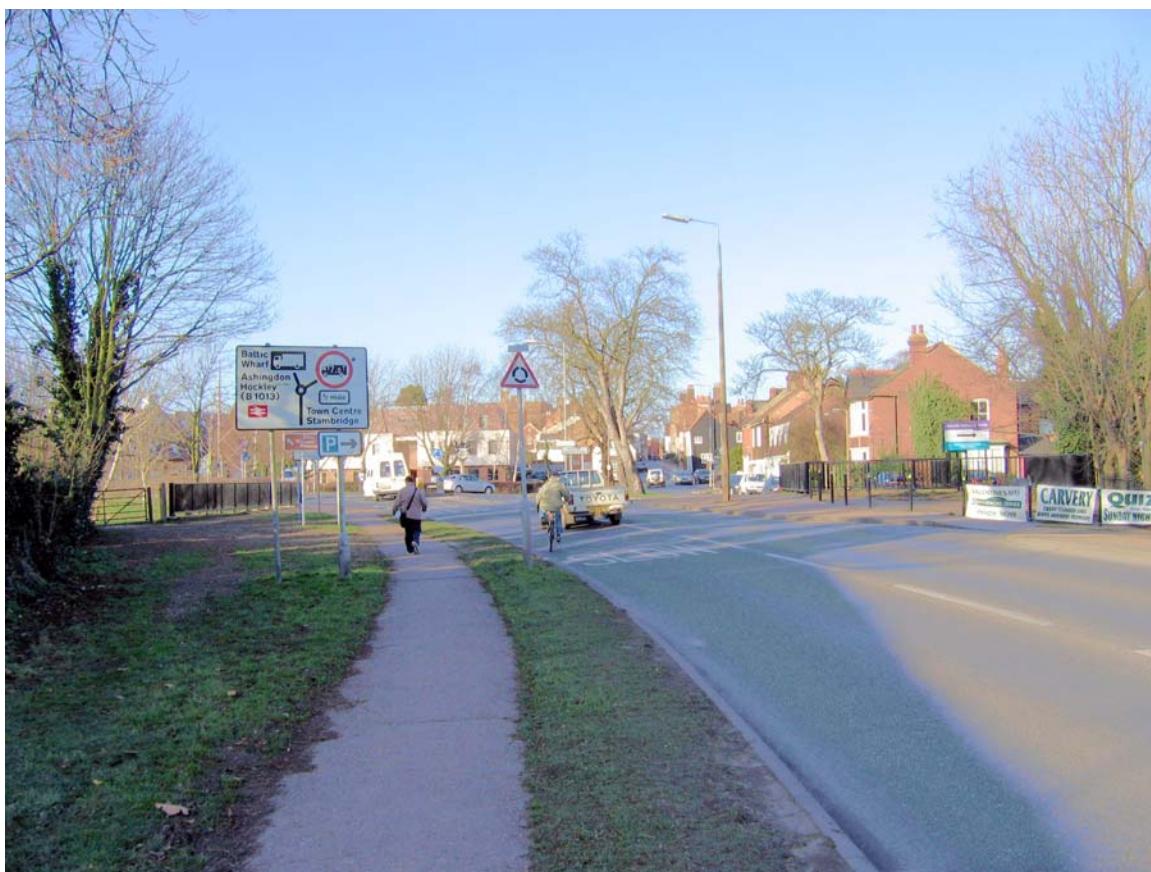
Fig. 22 The junction of Bradley Way and South Street. Street signs could be rationalised.

- 9.19 At the approach to the conservation area, the view glimpsed up the hill into the town along South Street contrasts with the lower lying bend round into Bradley Way, the junction between the two dominated by a modern office building, Cottis House, which although large just avoids being out of scale with its surroundings. Mature trees planted in this area contribute to this view. There is, however, an excess of road signs which could be rationalised and reduced (*Fig. 22*).

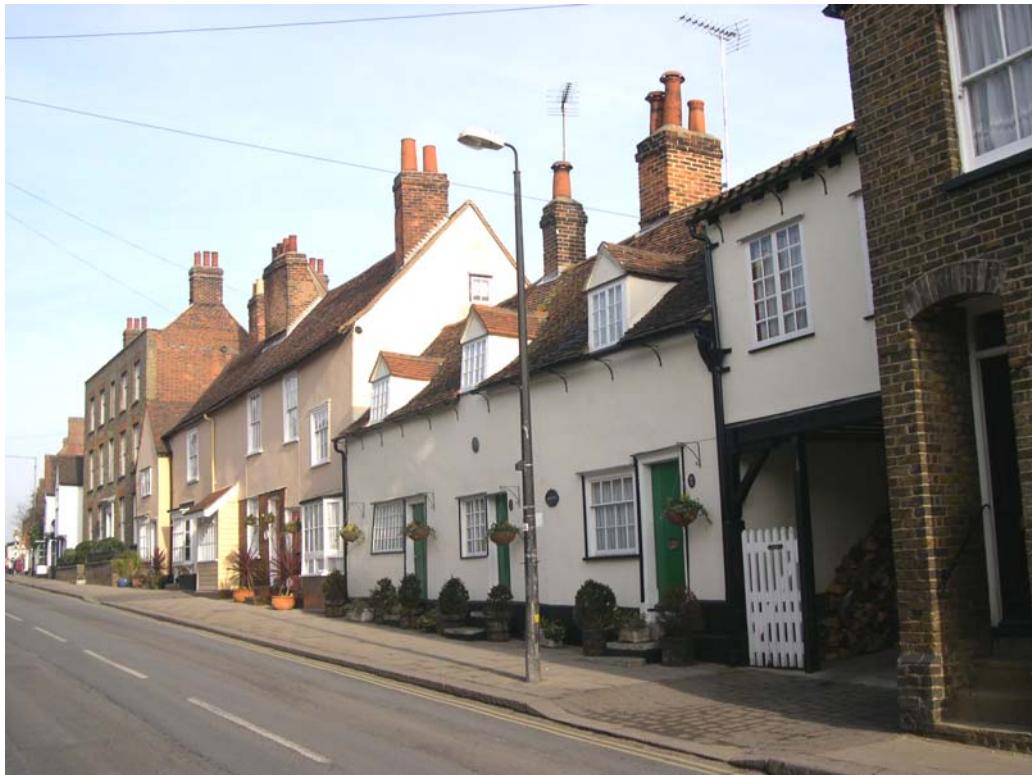
Fig. 23 South Street, east side, nos 19-35.

- 9.28 **Nos 33-35**, 17th/18th-century row of three one-and-a-half storey rendered timber-framed cottages, since the 1970s restored as one house, and lovingly maintained (*Fig. 23*). Carriage arch on south side a later extension.

- 9.29 **Nos 21-31**, row of grade II listed timber-framed and rendered cottages probably of late medieval date, two storey, under a single roof (*Fig. 23*). Cross-wing at north end. Large central stack may indicate alteration to lobby-entrance arrangement. Very well maintained. Carriage arch through to yard and cartlodge garaging.

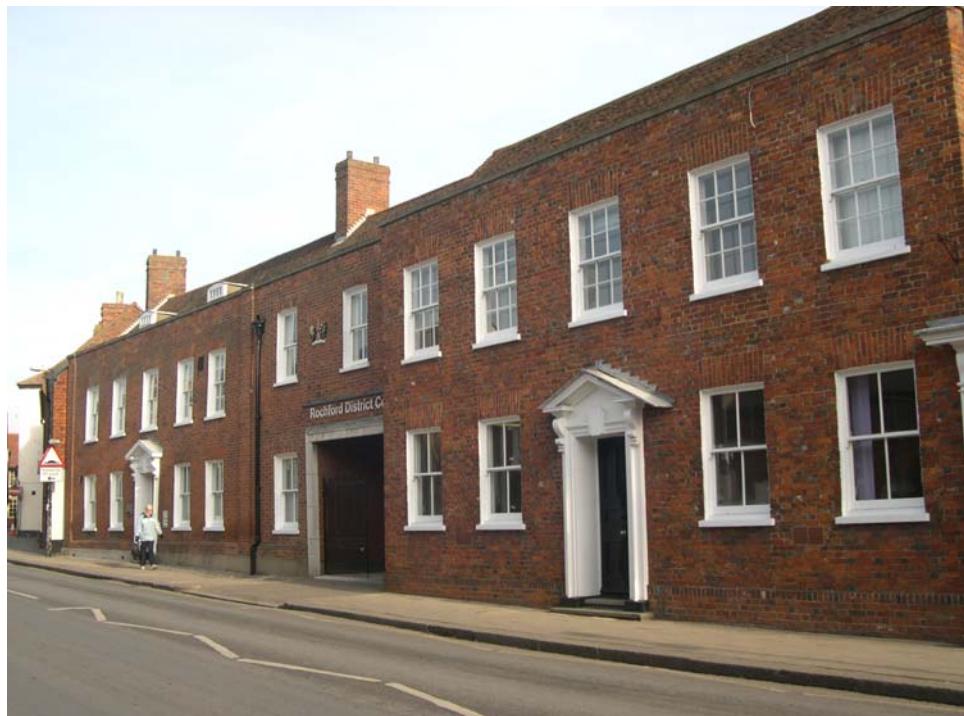
Fig. 24 North end of South Street, now Rochford District Council offices.

- 9.33 Behind nos 17 and 15 are attractive gardens maintained by the District Council, with some old red brick boundary walls.
- 9.34 North of Red House were a carriage arch with a projecting 19th-century bay window above, and **nos 9 and 11**, with front doors either side of a three window bay red brick façade (*Fig. 24*). These buildings were remodelled by the District Council in the 1970s. The carriage arch was closed up and three sashes inserted beneath it. Nos 9 and 11 were rebuilt to present a five window bay to match Roche House to the north, with a similar door case. This work has achieved a successful composition such that it is difficult today to work out what has happened. To the rear, these buildings have been extended in two phases, first presumably in the 1970s with an integral extension in a modern unsympathetic style, and then probably in the 1980s with a large free-standing building linked by a first-floor passageway.

- 9.35 **Nos 5-7**, Roche House, District Council offices like previous buildings. Five window bay grade II listed 18th-century red brick house, two storey with attics, parapet to roof, end stacks, pilaster strips at corners, gauged brick arches, doorcase with consoles (*Fig. 24*). To the south, a formerly separate unit with a carriage arch with a moulded stone surround, now incorporated into Roche House, the ground-floor door replaced by a window. Adequate iron gates to arch; unattractive concrete surfacing in archway. The arch forms the main public entrance to the Council offices. Formerly it gave access to car parking, but the car park is now occupied by a temporary reception office, and the whole area has a makeshift appearance quite at odds with the elegant street frontage.

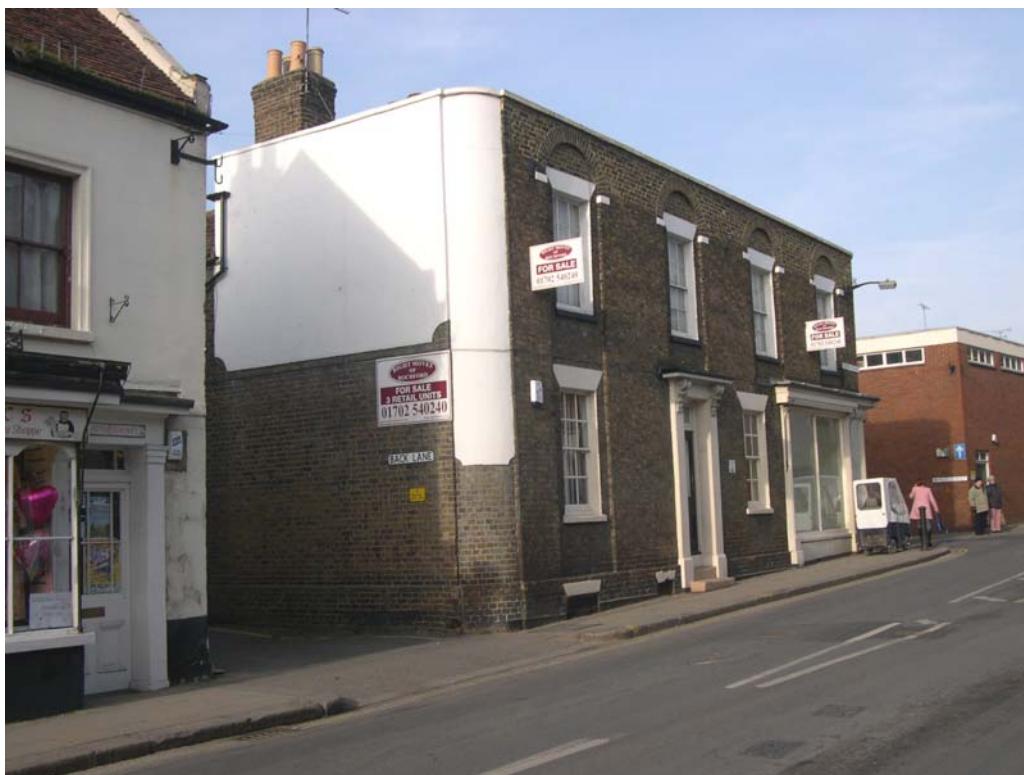
Fig. 25 No. 1 South Street.

- 9.39 **No. 1** South Street, and nos 1-5 West Street, all one corner building, 19th-century, listed grade II, stock brick, windows set in full height recessed panels with arched heads (Fig. 25). Plain stucco doorcase with consoles to flat hood facing South Street. Elegant shop windows with half round fluted columns and cornices, but painted garish blue and yellow at 3 West Street, and bad shop signs at 3 and 5 West Street.

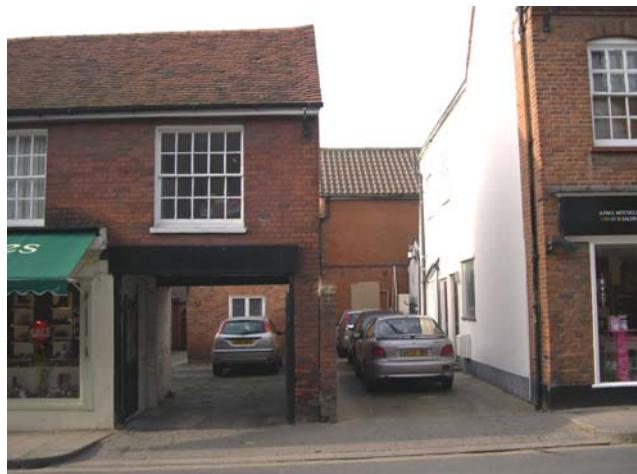
Fig. 26 South Street, carriage arch on the north side of no. 8.

- 9.43 Rear of no. 8, the carriage arch leads through to a yard occupied by rear extensions, outbuildings and new development. Although rather crowded, this has been successfully done. **Wistaria House, no. 6**, is an attractive red brick outbuilding converted to a house. It is dated by a graffito on the brickwork: MS 1832. The windows are of rather tall narrow proportion. Two new houses, 6A and 6B, have been shoehorned in further west. The view into the carriage arch, and the space between no. 8 and no. 4, is not enhanced by parked cars (*Fig. 26*).

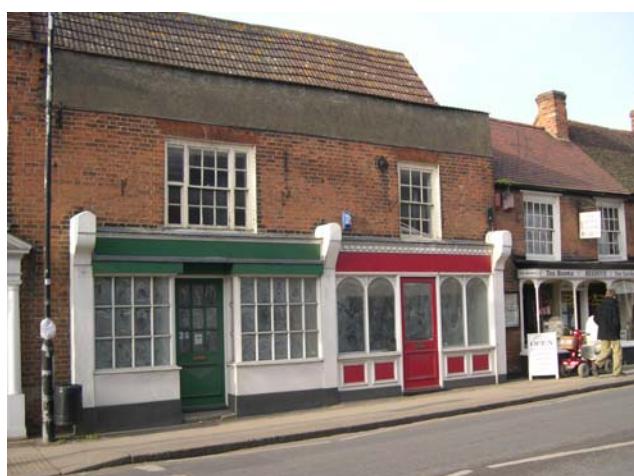
Fig. 27 South Street, shop fronts at nos 14 and 16, Beehive Tea Rooms to the right.

- 9.44 **Nos. 10 and 12**, two shops under one ownership and a continuous roof, though no. 12 unfortunately has machine made tiles. Beehive Tea Rooms and Records. Listed grade II, 18th-century but with older timber frame behind red brickwork. Small paned sash windows at first floor. Projecting small pane shop front to no. 10 with door with round arch. Double fronted shop front with segmental heads to no. 12 (*Fig. 27*).

- 9.45 **Nos. 14-20**, long building under single roof with central stack and central door with handsome doorcase with columns, pediment and fanlight. Listed grade II. 18th-century, but possibly older timber frame behind red brickwork. To right hand side, two shops, nos 14 and 16, the fascias and flanking piers old, but the attractive fronts are recent remodelling replacing full height sheet glass. The shops are, however, unlet. To the left of the central door, the ground floor is rendered, covering up former inserted shopfronts (when this part was a bank). Mainly tripartite sash windows to first floor, under gauged arches. Parapet to roof. Right hand part of roof with concrete tiles.
