Rochford District Council

ROCHFORD CONSERVATION AREA APPRAISAL AND MANAGEMENT PLAN

April 2006

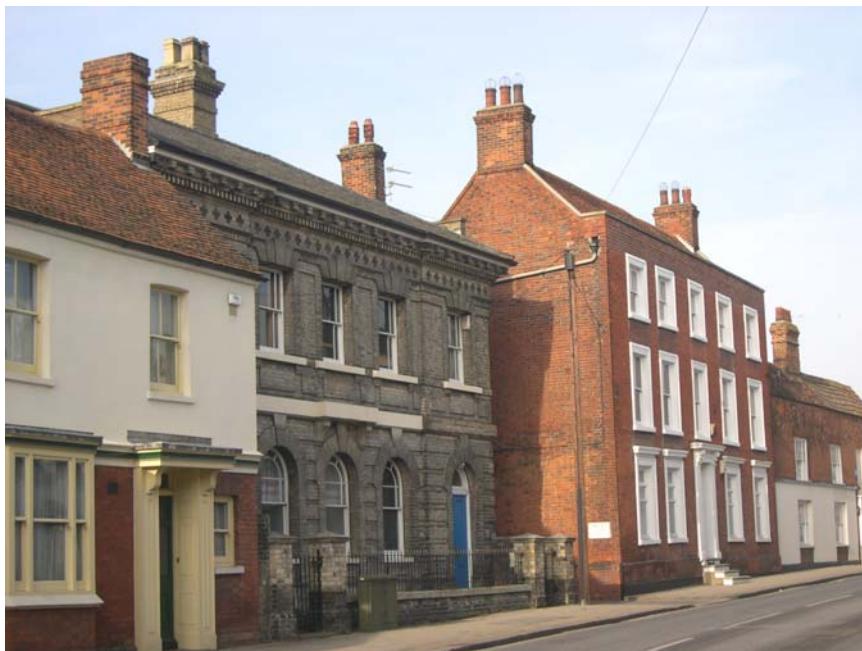
Fig. 28 South Street, no. 22 and the Masonic Hall, formerly the County Court.

- 9.46 **No. 22**, tall three-storey house, somewhat out of scale with its surroundings. 19th-century, or perhaps earlier (*Fig. 28*). Listed grade II. White painted stucco surrounds to door and windows, ground-floor windows with cornices, door case with consoles to flat hood. Parapet to roof. End stacks. Red brick, flared headers in side walls. Tuck pointing with black mortar fillets and traces of ruddling, but none of this well preserved. Long been used as offices.

- 9.47 **No. 24**, built as a Court House in 1859, formerly Rochford Rural District Council offices, now Masonic Hall (*Fig. 28*). Listed grade II. White or gault brick façade, stock brick to sides and rear, where there is a huge rectangular flat-roofed block which must house the original court room. This is fortunately invisible from the street, but prominent from the car park to the rear. There is also a modern rear extension, recently the subject of an application to improve access arrangements. The detailing of the façade is slightly heavy-handed and very sharp-edged: the ground floor has imitation rustication, with round-arched windows with raised surrounds; the first-floor has gauged brick arches with imitation voussoirs. The sash windows have marginal glazing. The façade is very well preserved, the only significant change being the loss of the original railings to the low brick boundary wall. They have been replaced with unfortunate spindly railings with silvered arrow tips. The appearance of the building would probably benefit from cleaning; white brick usually withstands the process successfully and comes up well.

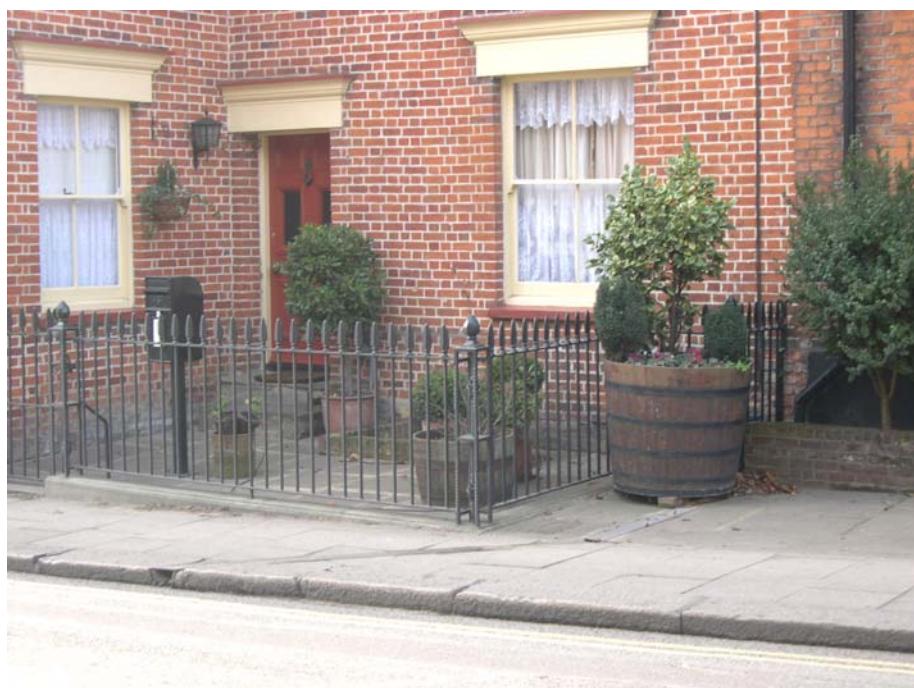
Fig. 29 South Street, well designed paving and railings at no. 30.

- 9.49 **Nos 28 and 30**, no. 28, Sydenham House, and no. 30, a small extension to it, were a school in the 19th century. Both grade II listed, and red brick. Sydenham House is 18th century or earlier, no. 30 19th-century. Sydenham House is of three window bays, with tripartite small paned windows, with end stacks. It has a handsome door case with a fanlight. Flat-roofed extension to the rear. No. 30 has stucco cornices to the door and ground-floor window. Brickwork repointed. Small flat-roofed dormer. It has been provided with well designed new railings round the stone paved yard in front of it, a model to be imitated elsewhere (*Fig. 29*).

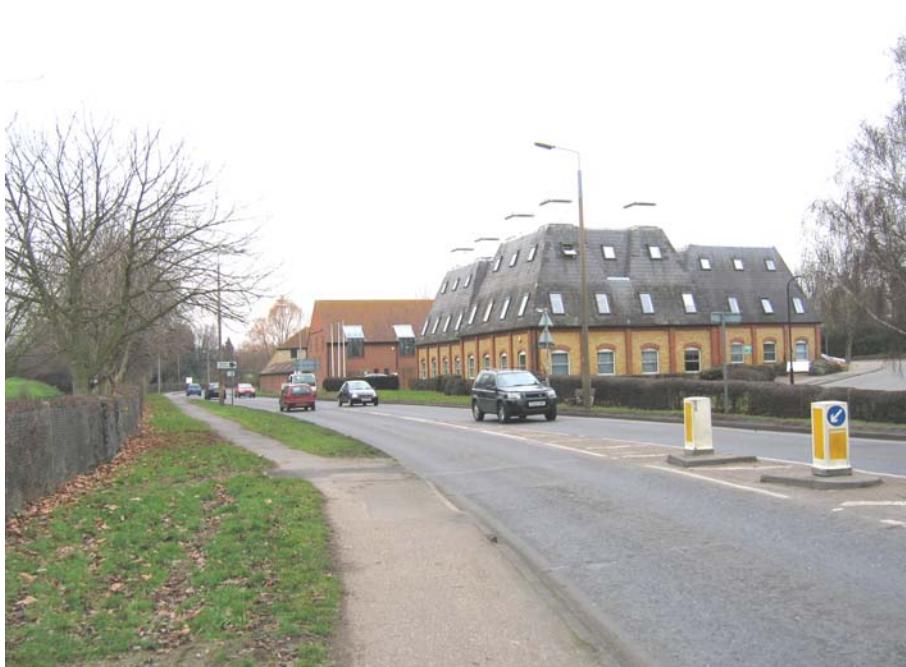
Fig. 30 Bradley Way and Canewdon House.

9.53 This is a modern ring road, but for roads of this type a not unpleasant one. It has not been arbitrarily imposed on a pre-existing landscape or built-up area. It was able to follow the course of the Iron Well stream which has been straightened to accommodate it. Its south side is lined with a thorn hedge and trees which screen it from the public open space. On the north side, there is planting (mainly pyracantha) and hedges, and several new buildings, a hotel and office blocks. The latter are built up to the frontage and thus relate to it. **Bradley House** and **Rumsey House** are linked by a wall, increasing the sense of a presence on the frontage. The oast house appearance of **Canewdon House** makes it an interesting landmark (*Fig. 30*).

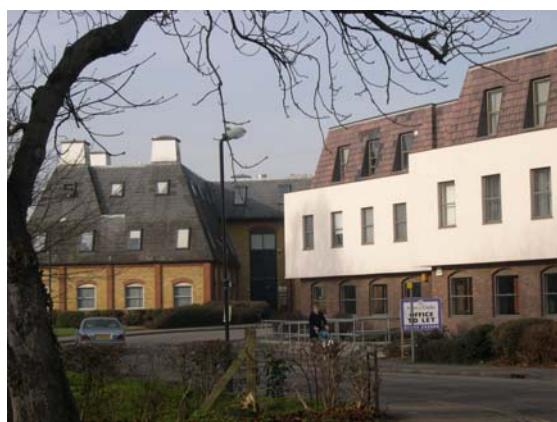
Fig. 31 Locks Hill, Cottis House and Canewdon House.

- 9.58 The modern office blocks (**Cottis House, Canewdon House, Rumsey House and Bradley House**) are all in recognisably modern styles, but ones which use traditional materials and acknowledge traditional design features (*Fig. 31*). They are two-and-a-half storey with mansard roofs, so although large their height has been constrained. Although visually discrete and quite distinct, these features and the similarity of scale endow them with a certain degree of uniformity. The hotel is different, a plain red brick building with somewhat unbalanced proportions. In the car park extension on land that formerly went with the houses on South Street, there are two buildings, Southwell House, a doctors' surgery, and Dolphin House, which represent a significant encroachment on the backland space.

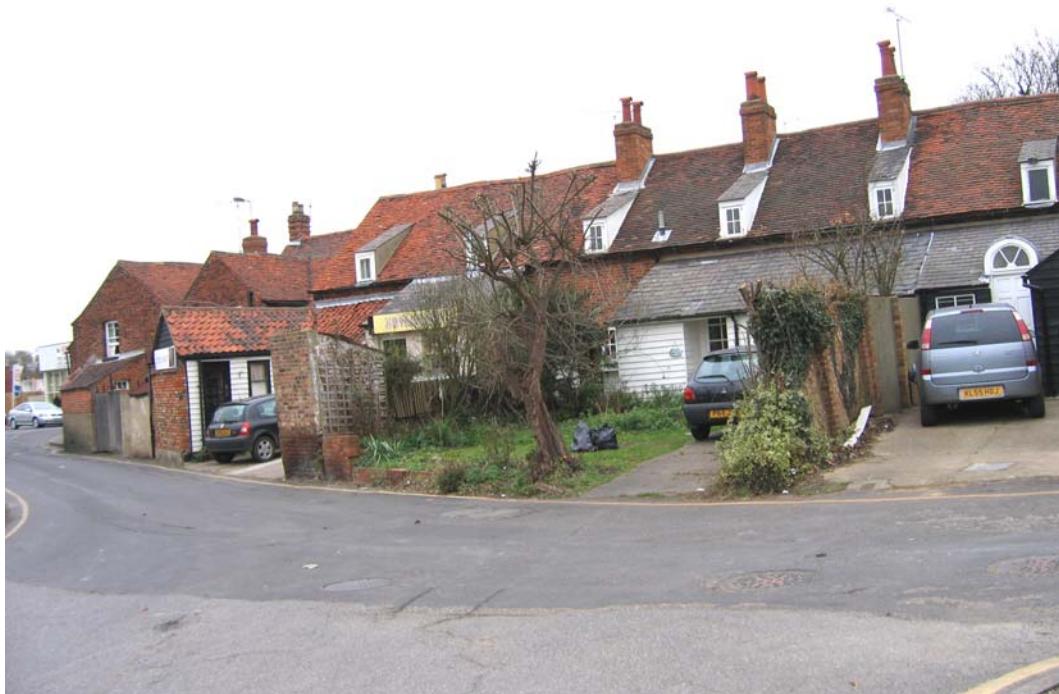
Fig. 32 Back Lane, rear of cottages at the rear of the west end of West Street.

9.59 Back Lane, it has been suggested above, has its origins in an infill row on the south side of the market place. The north side of it is occupied by the backs of the properties on West Street (*Fig. 32*). The south side has some buildings which front on to it, but the west end is occupied by the car park. There is great variety down the length of the Lane, of architectural style and scale, of building materials, and of use. Although there may be nothing of individual merit, the views down it are form a composition of considerable visual interest. The backs of the cottages at the west end, with their lean-to and gambrel roofed extensions, are particularly picturesque (*Fig. 32*). The back of no. 43 West Street is notable for a remarkable collection of outbuildings, including a wash house with a chimney.

- 9.60 The Lane is narrow, its surface patched, and there are no sidewalks. It feels like a pedestrian space, but in fact traffic can drive two ways along it, though access is only possible from South Street. It is generally free from parked cars, but where there is space behind the West Street buildings, there is parking on hard standings or in yards. The gardens of the cottages at the west end have been turned into parking lots (*Fig. 32*).

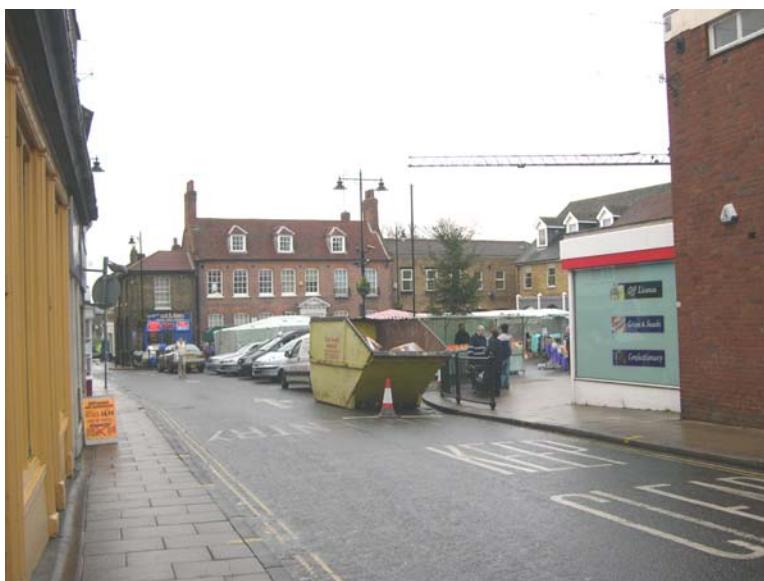
Fig. 33 Market Square on a market day.

- 9.65 The market seems to have lapsed at the end of the Middle Ages. It was revived in the 18th century. In the 19th century, there was a weekly corn market on Thursday, with a market for livestock every other Thursday (Benton II, 887). It then lapsed again, lasted until 1959, and was resurrected again in 1979. Today there is an active Tuesday market which is significant feature of life in the town. Litter removal is a problem associated with the market, a large yellow skip being parked conspicuously in the Square on market days (*Fig. 33*).

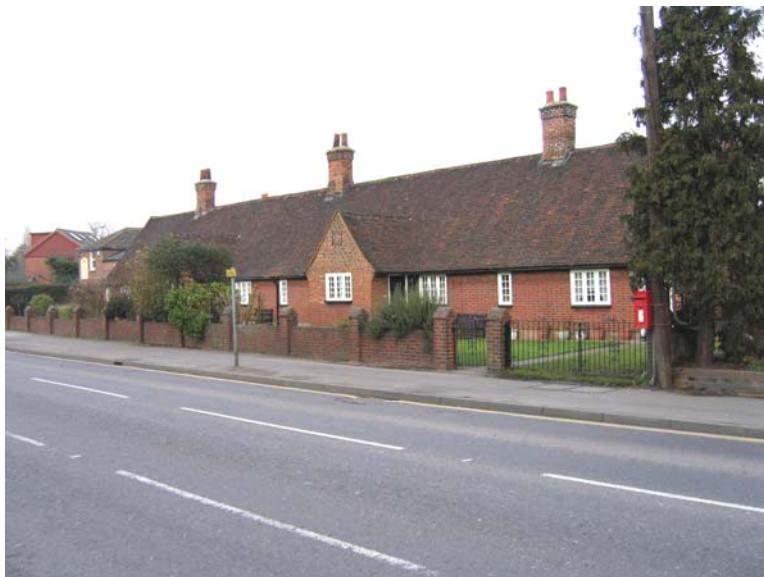
Fig. 34 West Street, Lord Rich's almshouses.

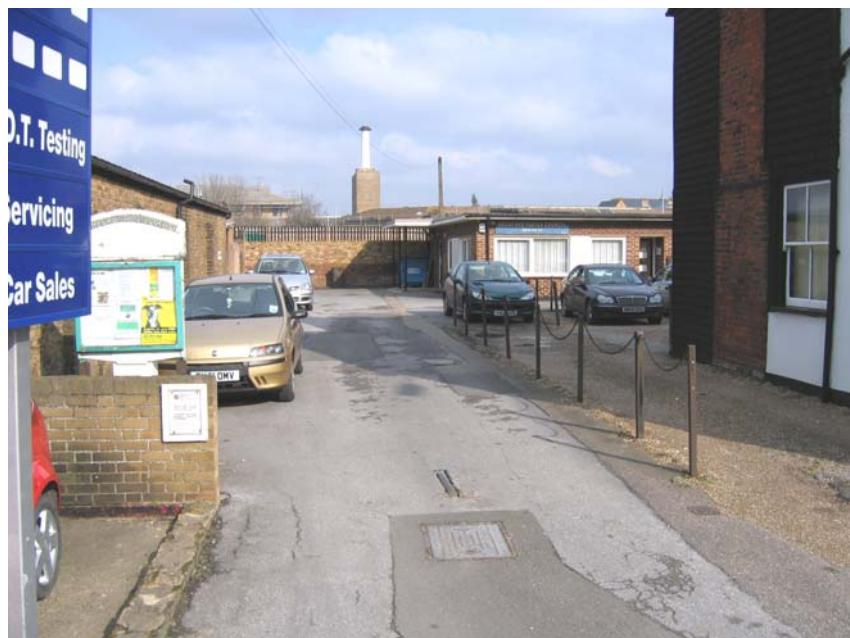
Fig. 35 West Street, depressing view between Whittingham's garage and Sovereign House to the parish council offices. In the background, the former hospital boiler house.

- 9.70 The **Parish Council Office** is a modern building set back from the road, partly behind Sovereign House; its noticeboard is very tatty and the view through to it is across a poorly surfaced parking lot (*Fig. 35*). **Sovereign House, no. 82**, is a grade II listed double pile house now used as offices, a use reflected in the cars parked on the crazy paving and cement hard standing outside the front of it, and also on the asphalted area to the rear of it. It is late 18th- or 19th-century in date, but the back may be earlier. The front is plastered, the back weatherboarded. The porch roof has been repaired with inappropriate brown-coloured roofing felt. The land around Sovereign House needs landscaping and better boundary treatment. The Essex County Council Social Services offices (**no. 80**) occupy what must formerly have been four houses, dating probably from the 1960s or 1970s. They are set well back from the road, but the brick boundary wall provides a sense of containment and screens the cars parked in front of the offices.

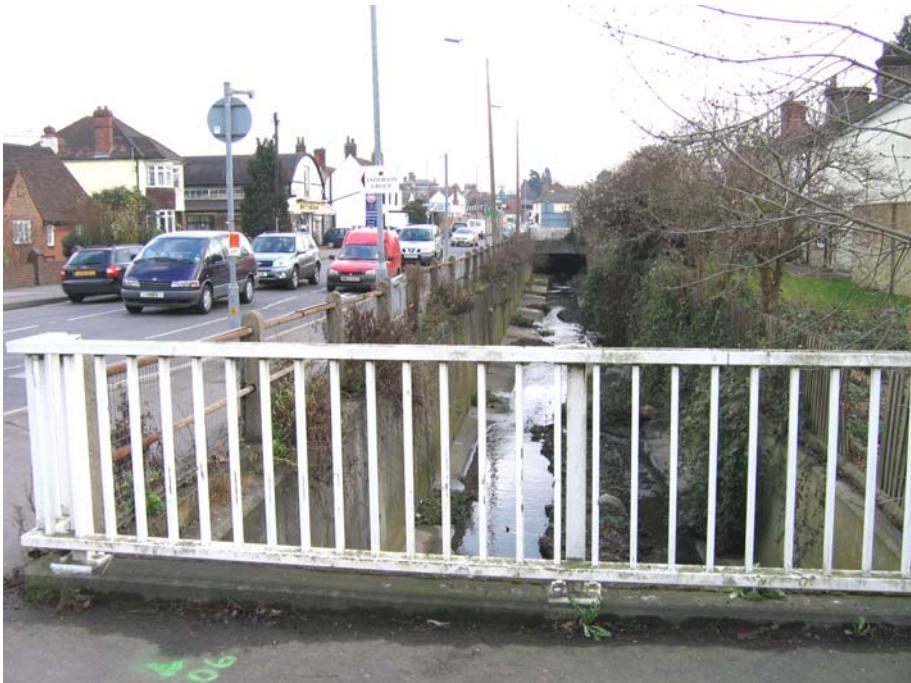
Fig. 36 West end of West Street, the concrete lined conduit for the Iron Well Stream.

- 9.73 On the south side of the road, the stream which runs next to the pavement ought to be a feature of interest in the landscape. However, it is channelled in a concrete sided conduit which is overgrown and traps litter (*Fig. 36*). Worse, the conduit is bordered by tubular railings set in concrete posts, to which have been attached, presumably for safety reasons, wire mesh screens. Whilst the conduit may be a fact of life, this boundary treatment is ugly and should be improved.

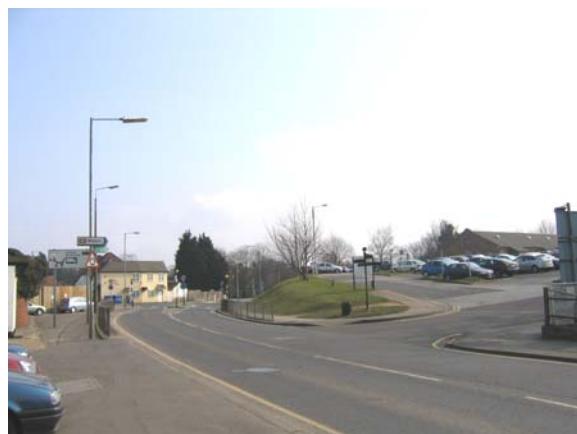
Fig. 37 West Street, view of Rochford Station car park.

- 9.75 Further east, the land rises from the road side back to **Rochford station**. Unfortunately, this low hill is a car park and the station buildings are mostly single storey and insignificant as a landscape feature. By the road edge there are utilitarian galvanised railings. A bare grassed bank separates the pavement from the car park, where there is a forest of signs, lights and cameras (*Fig. 37*). On the north-western boundary there is a tatty hedge of ivy-grown trees. The potentially attractive station buildings are not well maintained. The southern two-storey part, the former station master's house, is boarded up and to let (*Fig. 38*). The platforms retain their old canopies supported on cast-iron columns. The brickwork of the buildings facing the platforms has been painted terracotta. The appearance of the iron footbridge has been adversely affected by a high level safety screen. There is no sense of any coherent overall design to the works that have taken place at various times to the station and its environs. This area is badly in need of improvement.

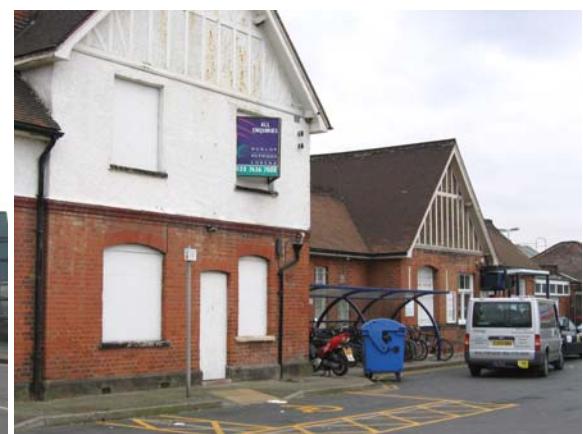
Fig. 38 Rochford Station, boarded up former station master's house.

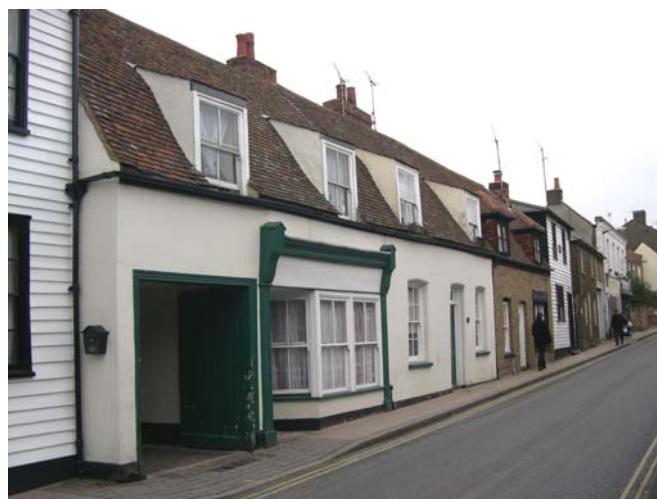
Fig. 39 West Street, north side, nos 50-62.

- 9.80 **No. 56**, identified by a plaque as 'Charterers Cottage 1810' (*Fig. 39*). Weatherboard, white to front, black to sides. Poor replacement wooden sash windows.

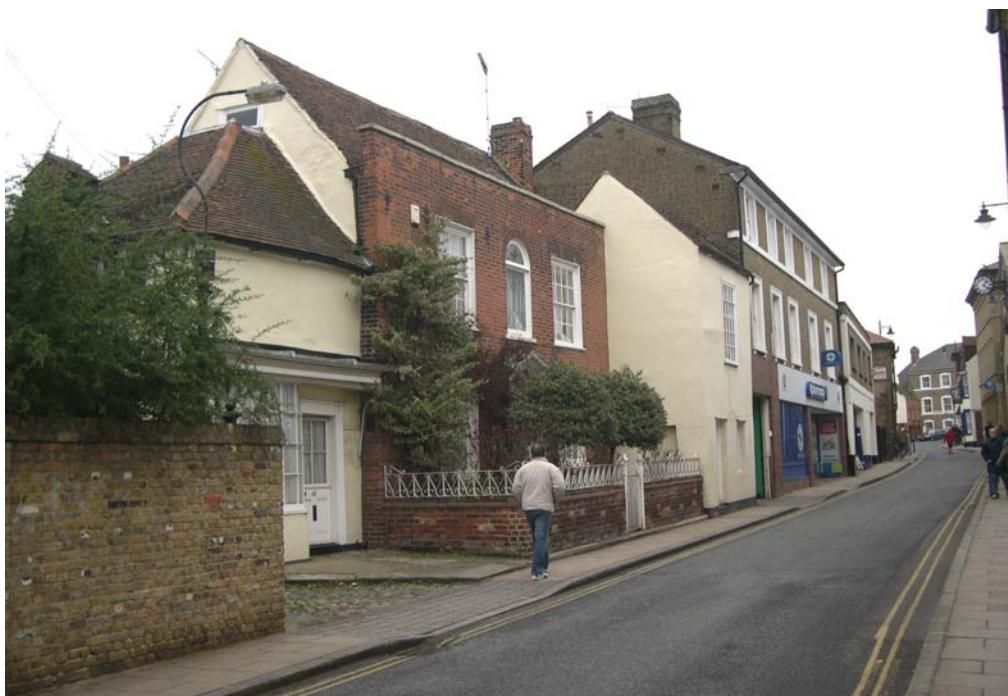
Fig. 40 West Street, nos 44-48.

- 9.83 **Nos 46-48**, the Hollies (no. 46), grade II listed, a small but aspirational red brick fronted house set back from the frontage to make it seem a little grander (*Fig. 40*). It is an example of the sort of development that took place in South Street in the later 18th century, a trend which largely by-passed West Street which was presumably not as fashionable. Repointing has led to a loss of character of the brickwork. The central first-floor round-arched window has had its sliding sash replaced with an unsatisfactory frame with leaded lights. The land to the front is enclosed by a brick wall with modern low railings on top. No. 48, also grade II listed, to the left, was formerly a surgery, now a house, with a very nice bow fronted window. Between 48 and 50, there is a very nice old weatherboarded stable at the back of a yard paved in stone and concrete, with plain new railings on the street frontage. These buildings form a very attractive group.

- 9.84 **No. 44**, grade II listed, 18th-century, timber frame rendered and lined out to the front (*Fig. 40*). Replacement wooden windows not very good.

- 9.85 **Co-op Pharmacy**, formerly a rather grand 19th-century house in stock brick, large, of five window bays, the windows with stucco surrounds (*Fig. 40*). The ground floor to the east of a carriage arch has been opened up into a large shop front with public convenience type tile surrounds, and an inappropriate sign. The left hand side of the shop windows have been blanked off, to the further detriment of the building.

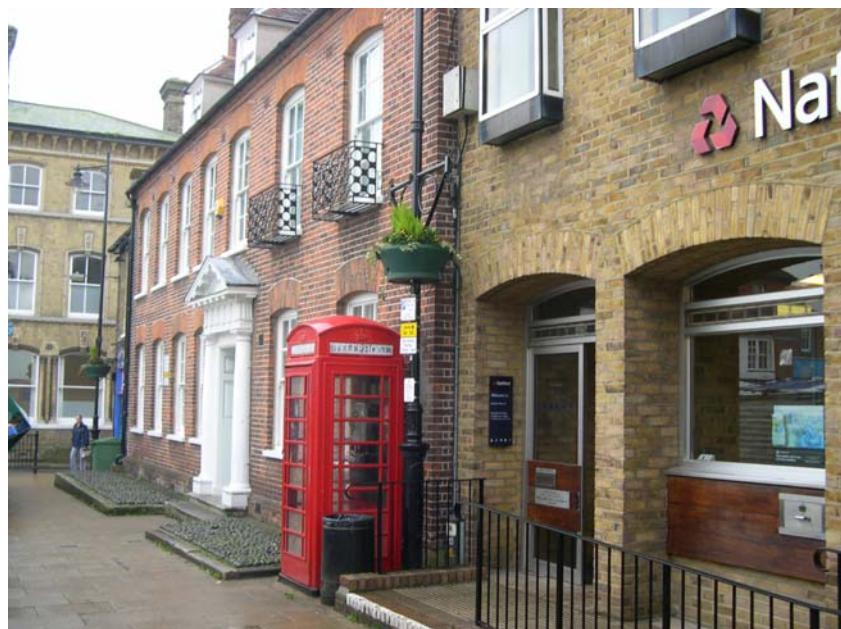
Fig. 41 Market Square, Connaught House and the NatWest bank.

- 9.88 **No. 34, Connaught House**, grade II listed, built apparently in 1769, is a large imposing house (*Fig. 41*). Its presence dominates the Square, and helps to give it a character other than commercial. Grade II listed, now used as County Council offices. The façade is curiously asymmetrical, the door not being central. To right hand side, a listed K6 telephone box.

- 9.89 The **NatWest Bank** in the north-west corner of the Square is a late 20th-century building, plain, in stock bricks which contrast nicely with the reds of Connaught House (*Fig. 41*). Parapet to a pitched roof. The row of segmental arched recesses at the ground floor giving it visual interest, and also mirroring the arched window heads of Connaught House. To the rear, a newly paved

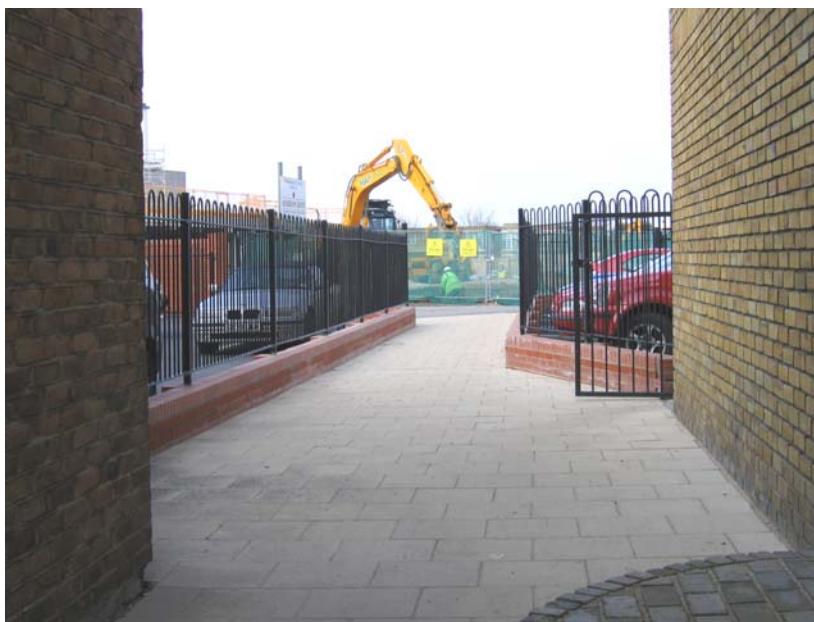
Fig. 42 View down alley at north-west corner of Market Square to the new development on the hospital site.

alleyway flanked by new hoop-topped railings, and flanked by newly surfaced shiny black car parks, leads to the supermarket and library development site and North Street. The view down this alley to the area of the superstore development is potentially important: the existing treatment of the alley is rather mean and uninspired, and not very promising for its future appearance (*Fig. 42*).

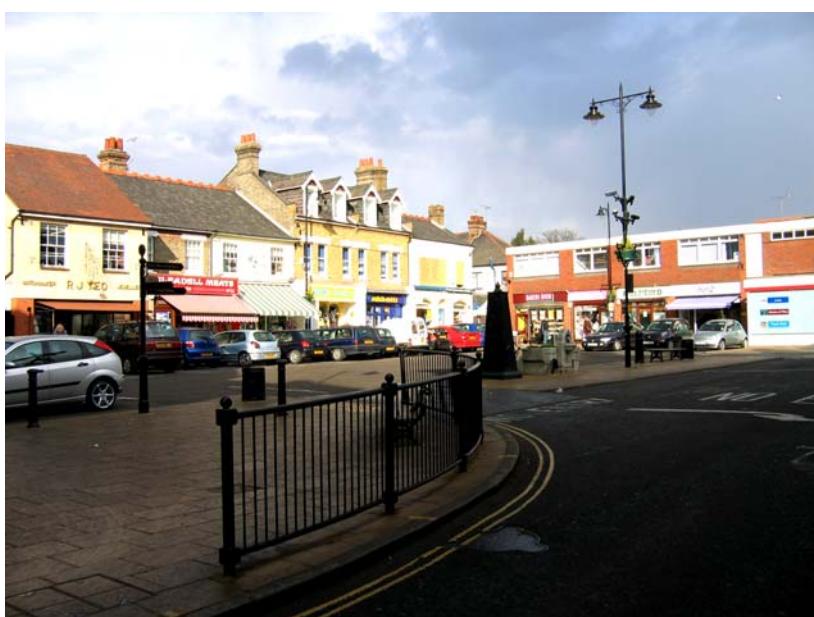
Fig. 43 Market Square, north and east sides.

- 9.92 **Nos 20-22**, Cleadell Butchers and Miss Daisy, a low two-storey late 19th-century stock brick building. The butchers shop front projects out at ground floor to bring it in line with Yeo Jewellers, and has been modernised, with a large plate glass window with unattractive tiles below. Miss Daisy has a nice traditional shop front, but the brickwork above has been painted cream (*Fig. 43*).

- 9.93 **Nos 16-18**, Home Plus 2 and Abbotts estate agents occupy a tall two-and-a-half storey late 19th-century building stock brick building with prominent dormers. Decorative stone lintels and cills to windows, fancy bargeboards to dormers. Shopfronts quite good, but let down by poor signs (*Fig. 43*).

- 9.95 The east side of the Square is occupied by a late 1960s building consisting of four shops, of which the most prominent is the Spar supermarket, as it sticks out into the Square reflecting the footprint of the buildings which formerly stood here (*Fig. 43*). The building is low, two storey, with a flat roof, of a reasonable quality brick, with tile hanging at first floor to the Square. The shop fronts are plain; there are metal framed windows. The main problem with the building, what makes it actively ugly, is the projecting part of the supermarket, a glazed box, the windows of which are largely blanked out. The elevations to West and North Streets are also unsatisfactory, that to West Street being a plain brick wall, and that to North Street being functional, with service doors and areas and no sense of presenting a façade to the street.

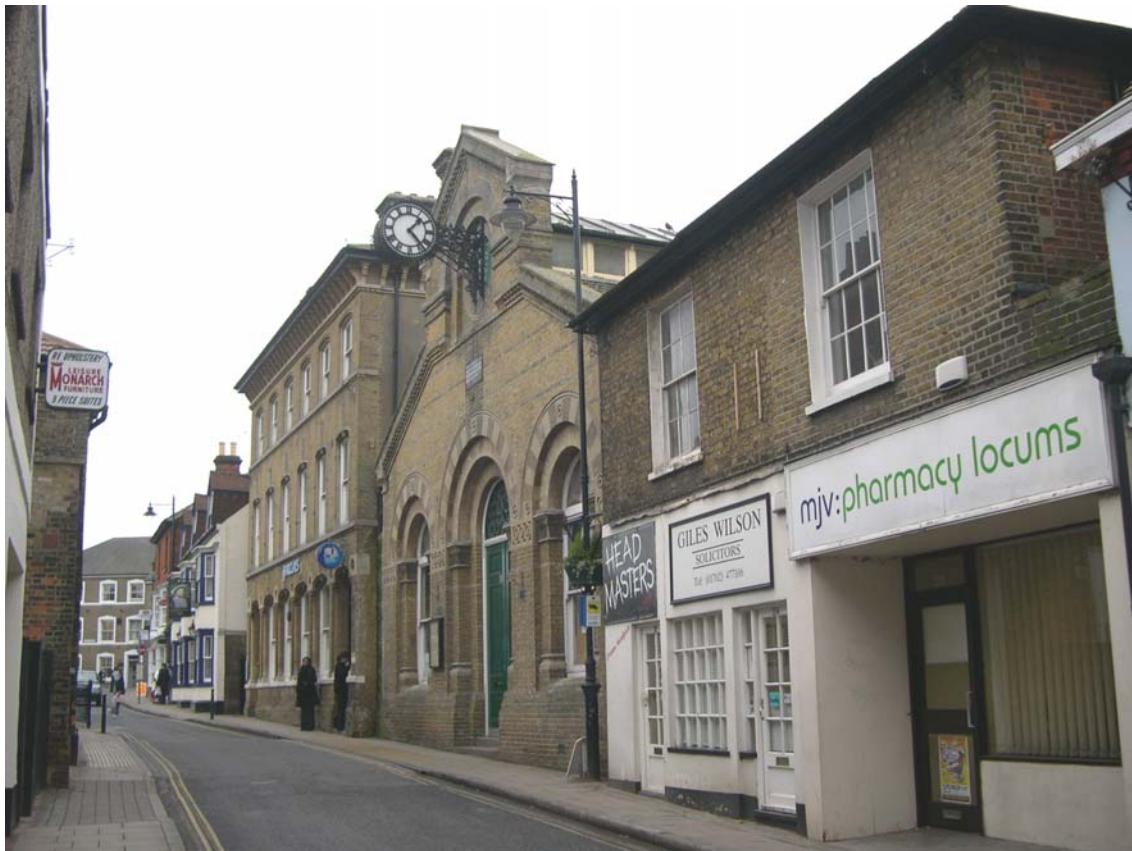
Fig. 44 West Street, nos 21-23, former Corn Exchange, and Barclays bank.

- 9.100 **Barclays Bank**, listed grade II stock brick with stone detailing and ornament, very imposing, three storey and out of scale with its surroundings, though the effect of this is to some extent absorbed by the slope in west Street (*Fig. 44*). Built in 1866 (Benton II, 898).

- 9.101 Former **Corn Exchange**, built 1866 to a design by Frederic Chancellor, the well-known Chelmsford architect, now the Women's Institute. Listed grade II. Stock brick with white brick and stone detailing and ornament. A good example of a building of this kind. A conspicuous feature is the clock projecting on an iron bracket erected for Queen Victoria's jubilee in 1897 (*Fig. 44*).

- 9.102 **Nos 21-23**, two storey, stock brick with sash windows at the first floor (*Fig. 12*), well preserved, but the ground floor a sad contrast, being rendered and white painted (*Fig. 44*), a series of shop fronts, the right hand one (mjj pharmacy locums) having been remodelled and set back behind the line of the façade with a large plate glass window.

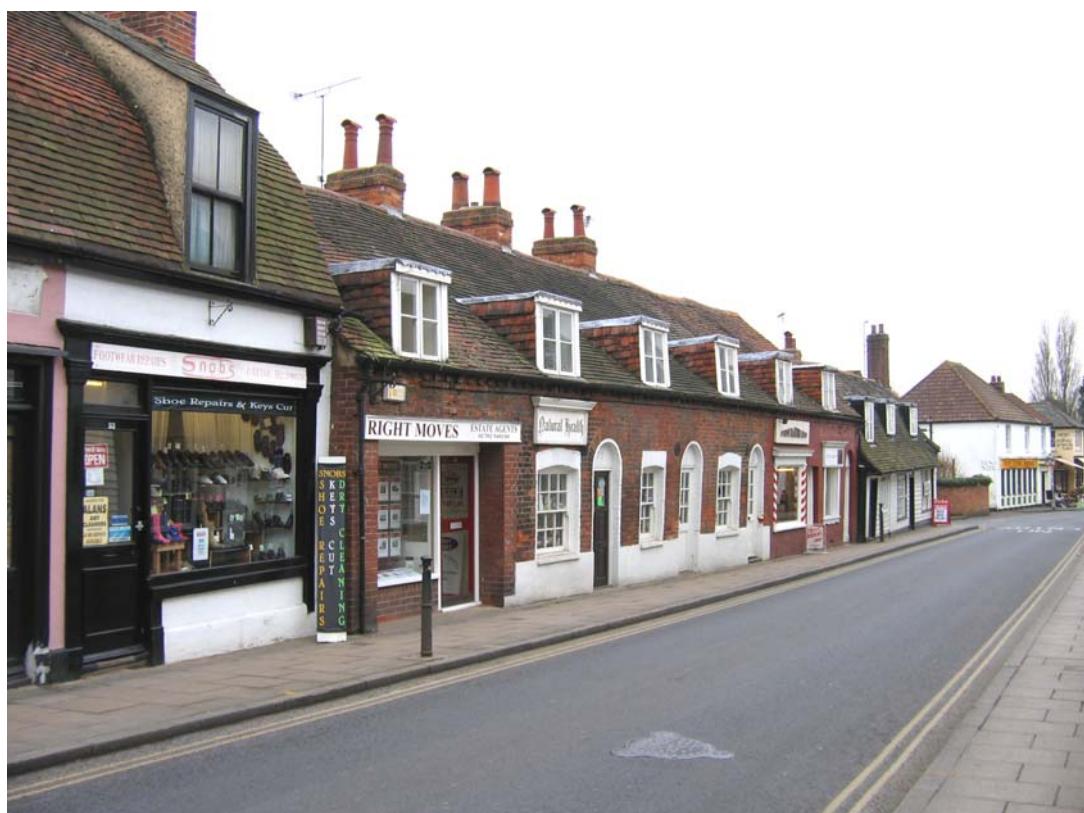
Fig. 45 West Street, cottages at west end (nos 53-69).

- 9.108 **Nos 51-53**, listed grade II, two shops, ground floor and attics in gambrel roof, probably 18th century (*Fig. 45*). The façade is painted, the left hand one, which is currently boarded up and missing tiles at the eaves, an undesirable shade of strong pink which does not fit with the rest of the street. Traditional shop fronts.

- 9.109 **Nos 55-65**, terrace of one-and-a-half storey cottages with gambrel roofs, red brick fronts, now all shops (*Fig. 45*). Grade II listed, probably 18th century. Brick dentil course at eaves. Doorways typically round arched. Nos 63-65 have terracotta painted brickwork. Only 55, 63 and 65 have inserted shop fronts, the others make use of the sash windows for display purposes. Rear lean-to extensions.

- 9.110 **Nos 67-69**, another terrace of similar grade II listed cottages, but the eaves level is significantly lower, which combined with the weatherboarding makes them particularly picturesque (*Fig. 45*). Probably 18th-century. The rear cross-wing extensions are a significant feature of Back Lane. The corner shop is a landmark at this end of West Street, though one with rather a lot of advertisements.

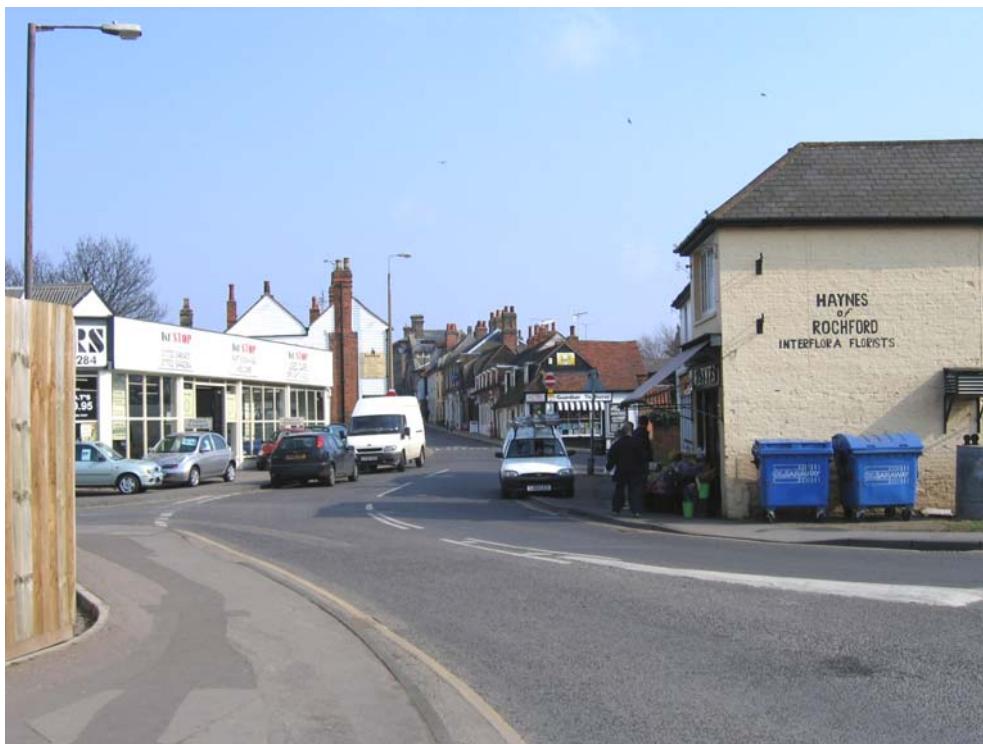
Fig. 46 West end of West Street, at the junction with Bradley Way.

- 9.77 At the edge of the historic town core are the extensive industrial sheds and the showroom of the **1st Stop** garage centre (*Fig. 46*). These are white-painted and well and tidily kept, if covered with excessive signage.

- 9.112 An isolated building, occupied by the Royal Tandoori Restaurant and Haynes Florists, stands in a prominent position on the south side of West Street at the entrance to the town centre. Two storey, brick, now white painted, concrete roof tiles. The restaurant has a garish plastic sign. Haynes is painted yellow. It is not enhanced by two skips outside it, and two ventilation units in its west wall (*Fig. 46*).

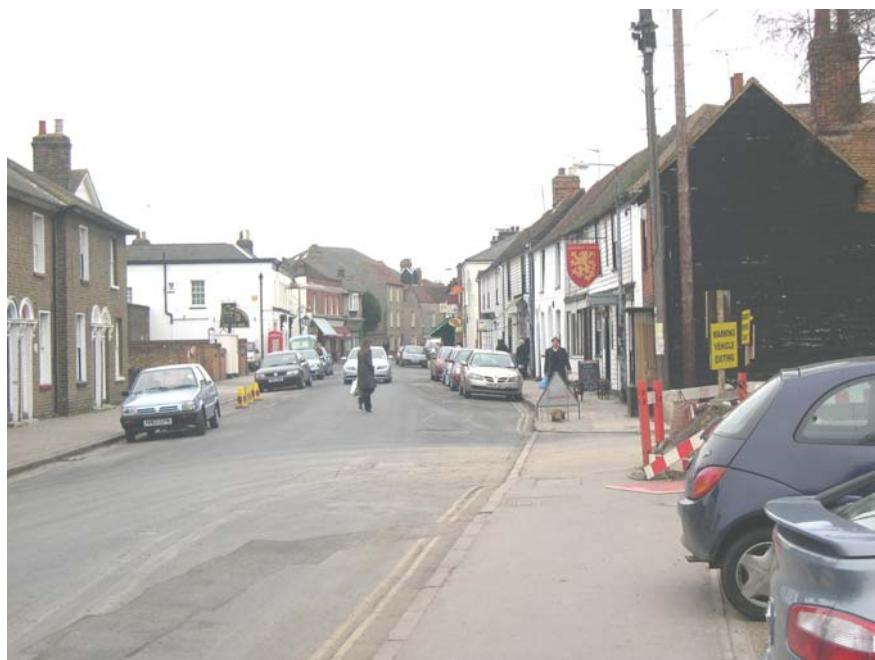
Fig. 47 North Street, looking south to the stock brick buildings of the Horners Corner complex, the Golden Lion on the right.

- 1.1 This is a long straight flat road, uncluttered by excessive signs or wires; the views up it are pleasant but undemonstrative, the road flanked by low buildings (*Fig. 47*). At the north edge of the conservation area, there is a slight bend and drop in level where the White Horse stands, a view that hints that it might lead to open country, which of course it has not done for a long time. At the south end, the road narrows, doubtless the result of encroachment in the course of market infill, and there is a change in scale with taller buildings. There is a contrast, too, between the commercial use at the southern end of it, a secondary shopping area, and the more residential character of the rest of the street. Typical of it are rows of 18th- or 19th-century weatherboarded cottages, as well as two notable terraces of 19th-century stock brick terraces. It seems to have become built up from the 18th century onwards. The presence of two Non-Conformist churches may also be significant as shortage of space in town centres often caused these to be built in peripheral locations. There is no evidence today that the road was settled in the Middle Ages.

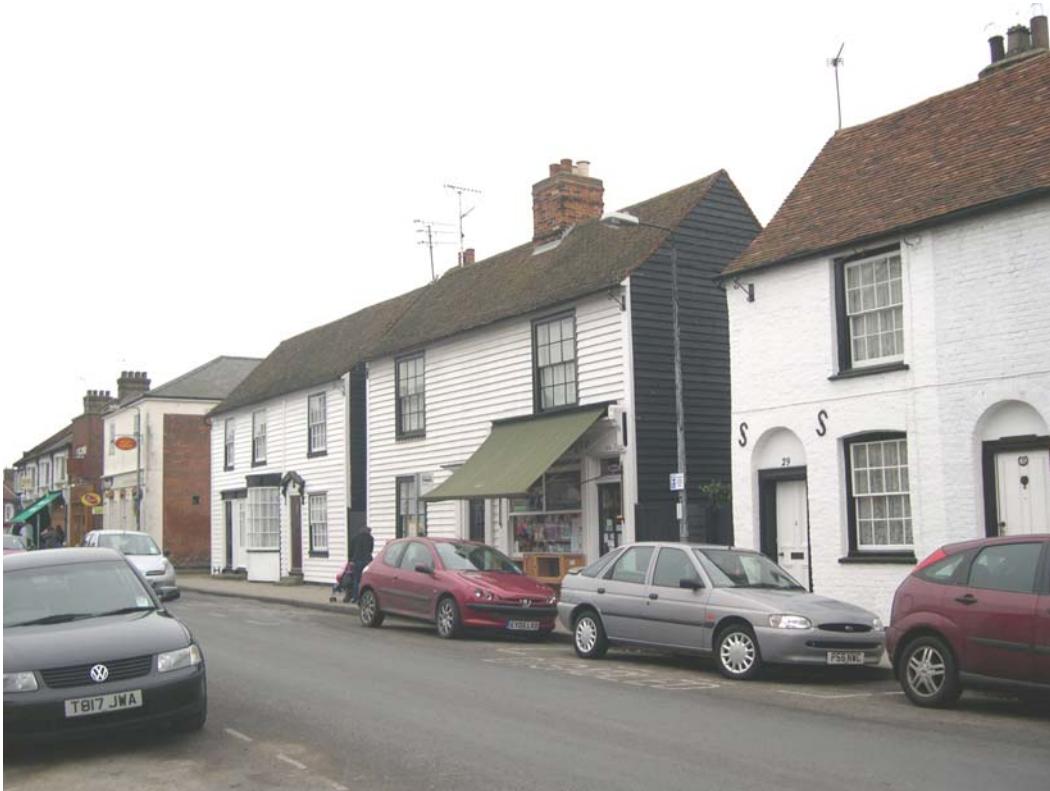
Fig. 48 Nos 21-31 North Street.

- 1.6 **Nos 21-23**, two, formerly three, nice weatherboarded cottages, white fronts and black sides, grade II listed, probably late 18th century (*Fig. 48*). Rear gambrel roofed extension; bow-fronted small paned ground floor window. Right hand cottage has a Norwich fire insurance sign.
- 1.7 **Nos 25-27**, grade II listed, probably late 18th century, nice weatherboarded double-fronted house, now with a shop (Animal Fayre) to the right (*Fig. 48*). The shop front is old, a full width sash window. Good door case with frieze with paterae. Gambrel roofed rear extension.

- 1.8 **Nos 29-35**, terrace of grade II listed 18th-century or later cottages, with the **Golden Lion** public House at the north end. First a pair of white painted brick fronted cottages (*Fig. 48*), the brick doubtless replacing an earlier material, weatherboarded side, round arched doors, sashes with panes of various types. No. 35 is weatherboarded, with a wide glazed shop front, currently empty, and in need of decoration. The Golden Lion is also weatherboarded, white painted with black joinery, an attractive double-fronted elevation with restrained signage, modern gambrel roofed extension to the rear. View through to asphalted yard used for parking and the hospital building site.

- 1.5 **No. 17**, post office and Premier store; the good if not very special quality of the original post office has been eroded by successive alterations (*Fig. 48*). Red brick, white painted pebbledash to the front, where there is an excess of unsuitable signs, the white box metal ones creating a visual ambiguity with the white wall. North elevation functional, south has sash windows and ramped block paved access to the entrance door. On this side there is a yard shared with no. 15, currently an ugly space filled with bins and a skip. To the north, a gap with views through to the hospital development site and car parking on the north side of the Square. This will be one of the ways into the new supermarket development. Unless some landscaping is carried out, it will not be very enticing. The flank wall of the post office is ugly, whilst there are modern extensions to the rear of the Market square shops. Adjacent to the post office, a nice ER II letterbox with two posting slots, and a grade II listed cannon used as a bollard.

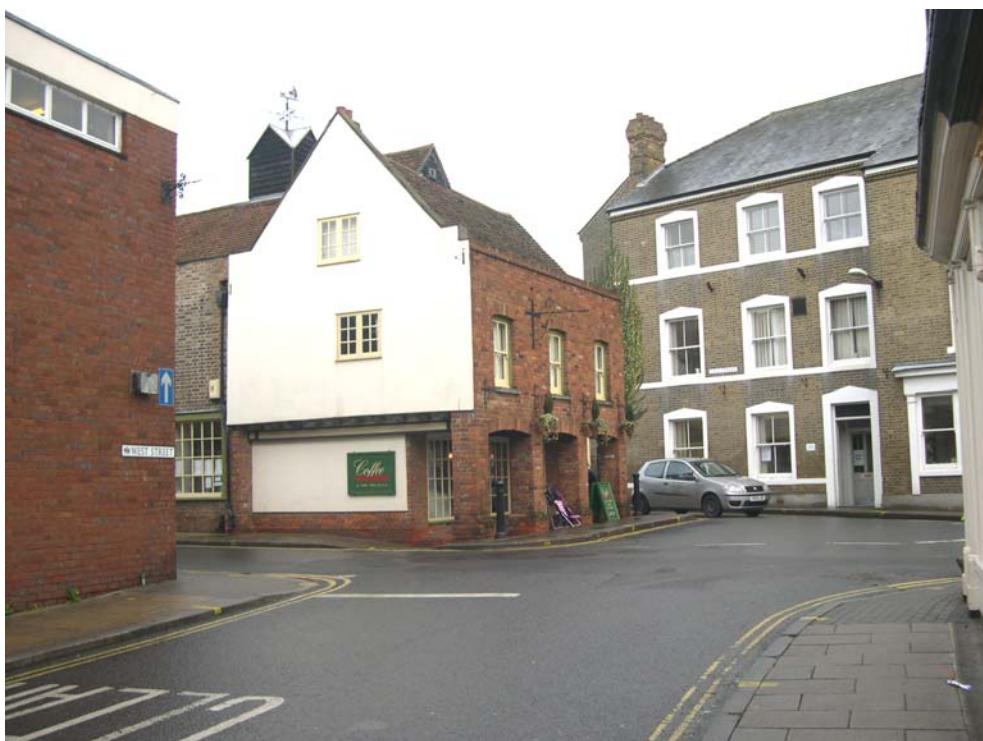
Fig. 50 Horners Corner, Acacia House in the background.

- 1.17 **Nos 2-4, the Horners Corner complex**, listed grade II (*Fig. 50*). The building facing on to the South Street junction was revealed as 16th-century and timber-framed when restored in the 1980s (see East Street). A sign still marks the English Heritage grant to its restoration. To the rear is a 17th-century building cased in stock brick and then a 19th-century three-storey stock brick building.

- 1.45 **No. 1, Horners Corner**, is a complex of buildings which was a former butcher's shop (*Fig. 50*). It was empty and boarded up for about ten years in the 1970s and 1980s, but then was restored in phases from 1986 by Lawrence and Adrian Chapman, with the help of a town scheme grant and English Heritage. Observations on the building and its archaeology were made by Essex County Council but remain unpublished. In brief, opening up of the structure facing on to South Street revealed a timber-framed building of the 16th century, whilst foundation trenches exposed layers representing a sequence of small buildings dating back probably to the 13th or 14th century and representing the gradual building up of an open market place. The building occupies what is arguably the most prominent position in the town, at the intersection of the four principal streets, and closing the view at the end of South Street. The restoration has seen the removal of the render from the façade exposing the red brickwork encasing the timber frame, and the replacement of the shop window with two brick arches, a new shop front being set behind these. The porticoed appearance is somewhat alien in an Essex town, but has the advantage of creating more pedestrian space in an area where the pavement is narrow. The cupola above the roof is not architectural whimsy; it covers a matchboarded shaft which rises the height of the building and may have been for smoking meat.

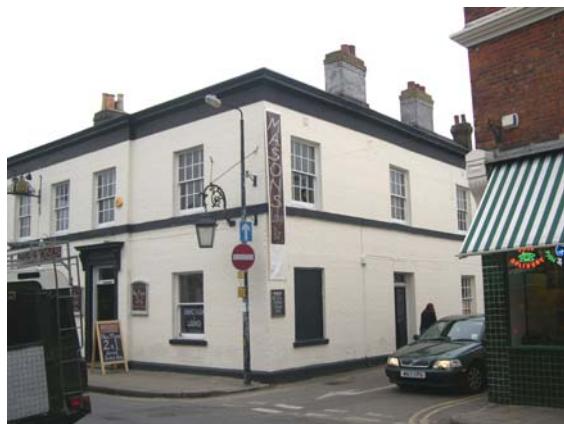
Fig. 51 North Street, The Old Ship.

- 1.21 The **Old Ship** public house, listed grade II, 19th-century in appearance, large, imposing and historic but exterior painted leading to a loss of character, abetted by the signage associated with its new identity as Masons Lounge Bar (*Fig. 51*). Of six window bays, the central four projecting forward. Moulded parapet to low hipped roof. Stucco string course. Consoles to the hoods of the two doors. Nice cast iron lamp and bracket at right corner. Well preserved 19th-century rear extension on this side in stock brick. Carriage arch on left hand side. A K6 telephone box stands next to the pub on the north side, where is an old stock brick wall, the back of a lean-to stable, set well back from the frontage; the space in front of it has unfortunately become a hard standing for parked cars. Depressing view into the pub garden through an open carriageway (*Fig. 52*); the front part of it is gravelled and used for parking; the rear, partially screened by evergreens, is a beer garden with a derelict children's play area and three garages. Litter is a prominent feature of this space.

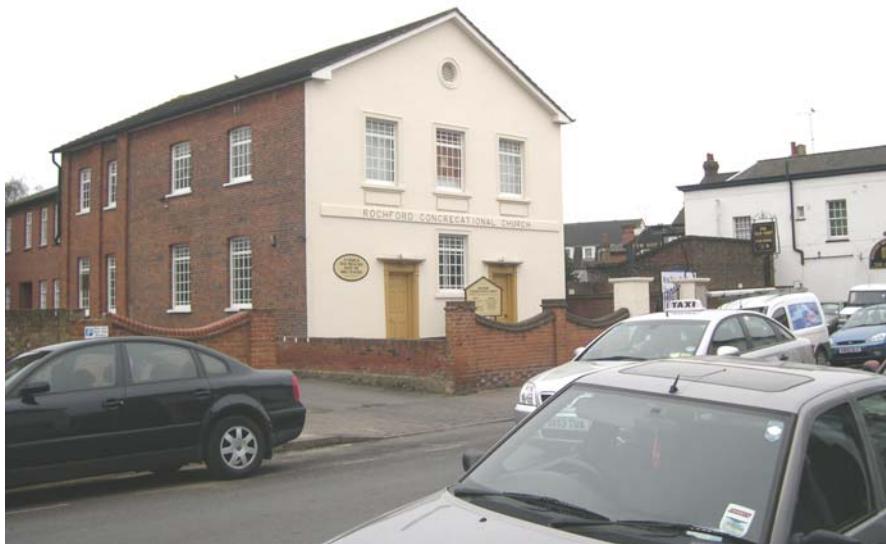
Fig. 53 North Street, the Congregational chapel.

- 1.22 **Rochford Congregational church**, a plain gaunt building, the more so because of the sea of asphalt in which it stands (*Fig. 53*). The car park extends right to the back of the plot on the north side. The asphalt covers a burial ground which has been completely cleared. The chapel is a red brick building, but the front is stuccoed and lined out, with two entrance doors. The original building was square in plan, and dated from 1741 (Benton 1888, II, 888; Kaye 199, 62). It was extended by two bays in 1838, at which time the existing galleries must

have been put in. A large extension has since been made to the rear in the late 20th century. The site is enclosed by modern brick walls, but the old stuccoed brick gate posts, with their iron gates and lantern on an iron arch above them, are notable. The setting of this building desperately needs to be softened by some planting. In view of its age, the chapel could be considered for listing. To the rear of the site, there is a nice detached stock brick building of four window bays; UPVC windows to the first floor.

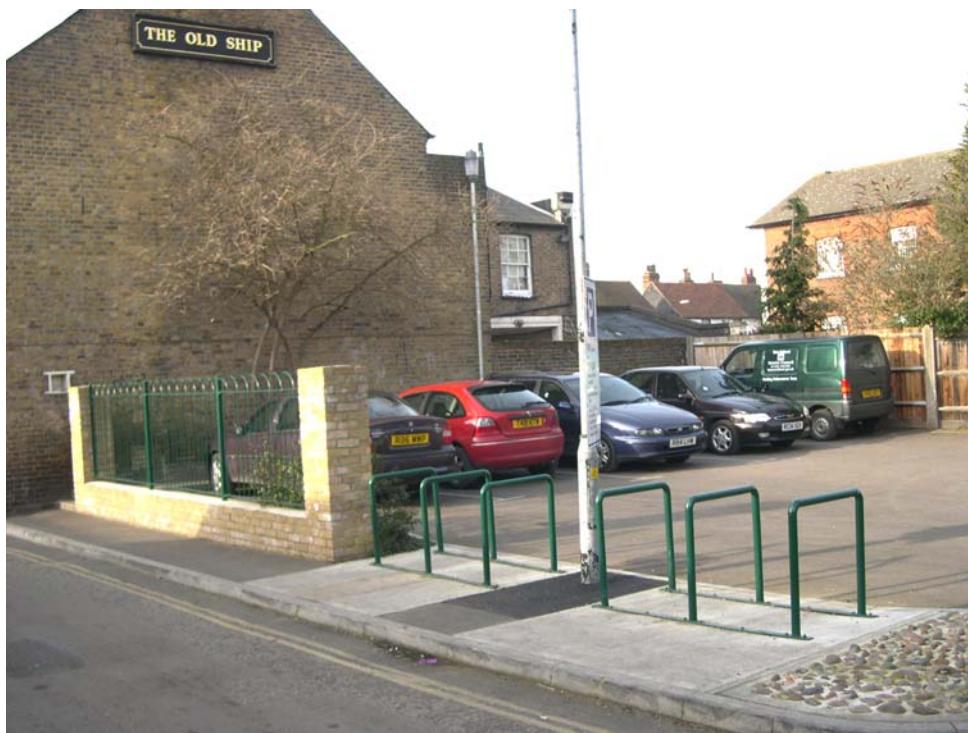
Fig. 54 Old Ship Lane car park.

- 1.30 From North Street, the lane begins well, being enclosed by the buildings to the rear of nos 8-10 and the Old Ship and by stock brick walls with wooden gates. On the north side, however, the sense of enclosure is broken by a newly laid out and very unsatisfactory car park (*Fig. 54*). The boundary to the lane is a low brick wall marred by salt efflorescence, with crude cement flaunching on top of it, above which are spindly hooped railings which have been already vandalised. The effect of this car park is made worse by a degree of visual continuity with the bare asphalt car park to the south belonging to the New Ship. Despite the presence of these car parks, parking is allowed on the south side of the Lane.

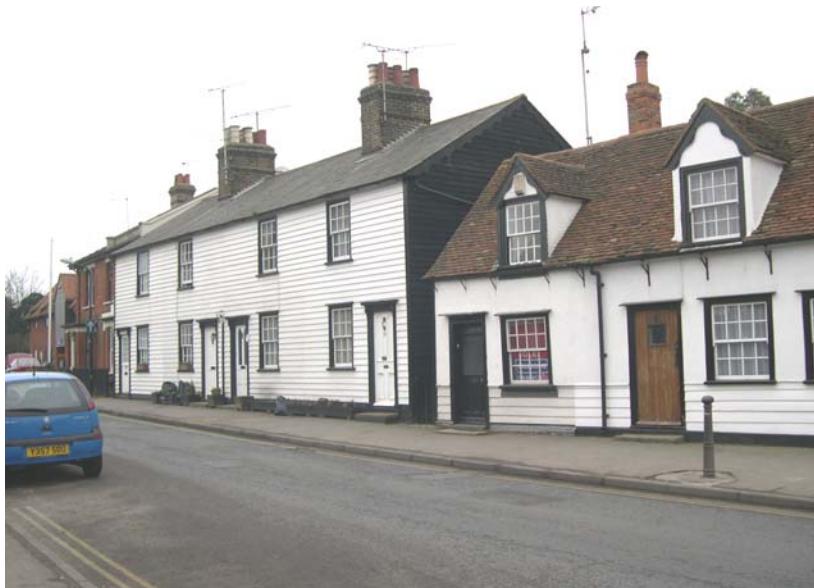
Fig. 55 Weir Pond Road, cottages at the west end (nos 6-16).

- 1.34 Four cast iron bollards on the south side of the road are a reminder that this is part of the conservation area. **Nos 2-8** are a row of rendered one-and-a-half storey cottages with dormers with fancy bargeboards. Grade II listed; probably 18th-century. They are a picturesque group presenting a unified appearance, but may not all have been built at one time. They are rendered, white painted with black joinery in the style typical of Rochford. At the bottom of the front walls, there is a weatherboarded skirt or plinth. **Nos 10-16** are another row of low attractive grade II listed cottages, the weatherboarding painted white at the front and black at the sides, the joinery black. Slate roofs and stock brick chimneys, which together with the slack roof pitch indicate a 19th-century date (*Fig. 55*). **Nos 18-20** are a pair of early 20th-century semi-detached houses, with red brick fronts and fletton sides, slate roofs and ground-floor bay windows. No. 18 has UPVC windows and doors.
