Rochford District Council

ROCHFORD CONSERVATION AREA APPRAISAL AND MANAGEMENT PLAN

April 2006

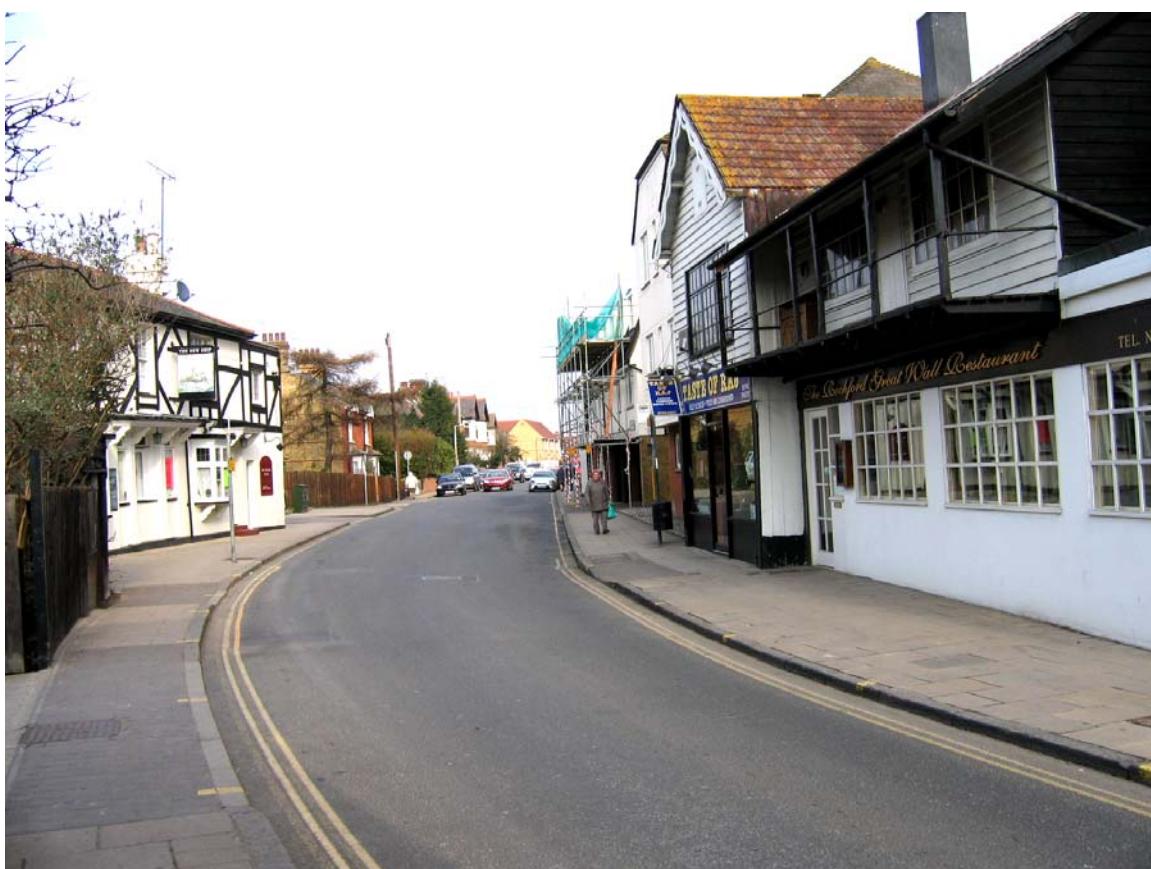
Fig. 56 East Street, looking east, Great Wall restaurant and Taste of Raj takeaway, the New Ship on the left.

- 1.40 **Woodys Wines**, interesting late 20th-century block, its corner chamfered to present an aspect across the open space in front of it. It is however rather tall, its brickwork has been painted cream, and the timber windows are of indifferent design.
- 1.41 The **Great Wall Restaurant**, and **Taste of Raj** takeaway, form an attractive group of adjacent timber-framed buildings, of 19th-century or earlier date (*Fig. 56*). Both are weatherboarded at the first floor. The Great Wall restaurant is rendered at the ground floor, and has a slate roof which forms a pentice to a nice wooden balcony, an unusual feature. The Taste of Raj is of cross-wing form; the ground floor is taken up with large plate glass windows and has a rather garish shop sign; the roof has concrete tiles.

- 1.47 The **New Ship** is a 19th-century building given a 20th-century make-over, rendered at ground floor, false half timbering above (*Fig. 56*). Although retaining most of its original windows and joinery, it looks rather unconvincing, probably because its decoration has been oversimplified in recent times. The main central door has been blocked up, which has not improved its appearance. 19th-century buildings to the rear. The New Ship car park is a desolate unenclosed strip of asphalt on the frontage, across which there are views of outbuildings at the rear of the pub (*Fig. 57*).

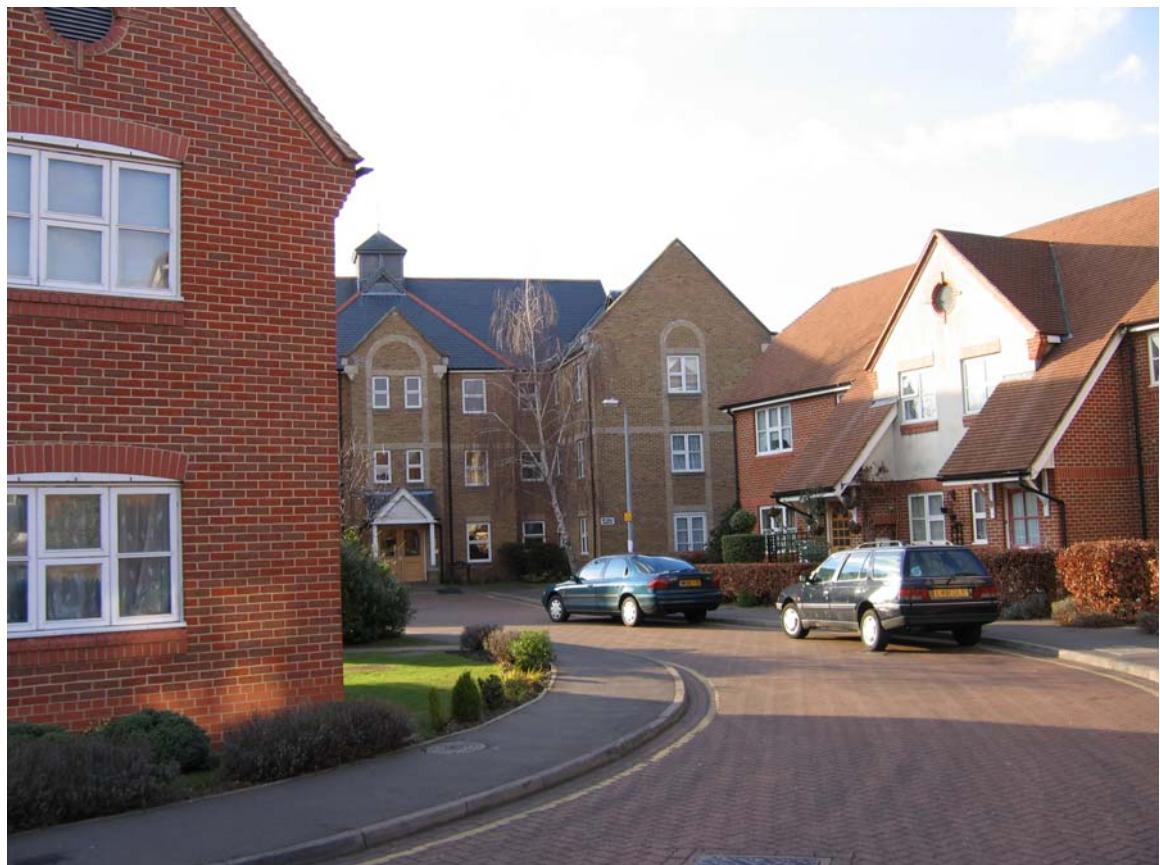
Fig. 58 Lever Lane and Winnowers Court.

- 1.52 Within the conservation area are **nos 20-28**, a distinctive row of tall three storey houses in red and stock-type brick, with steeply pitched roofs and integral garages. Lever Lane leads past pleasant terraces of two storey housing to **Winnowers Court**, a three storey block of flats in stock brick with a slate roof (Fig. 58). Its height makes it a prominent landmark, both from this side and South Street. Although a satisfactory design, its size and the materials make it slightly forbidding, reminiscent of a workhouse. Lever Lane also gives access to **Millview Court**, a very large block of two storey flats dated 1986 and 1988, and built round a courtyard. It is carefully designed. The first floor has a pargeted finish, the render with the slightly dead look that results from the use of cement. To the south of it, there is a large well kept garden. On the north side, there is an area of car parking which links up with the car park of the Rochford District Council offices. This extensive area of hard standing and brick walls should be softened with some planting and trees.

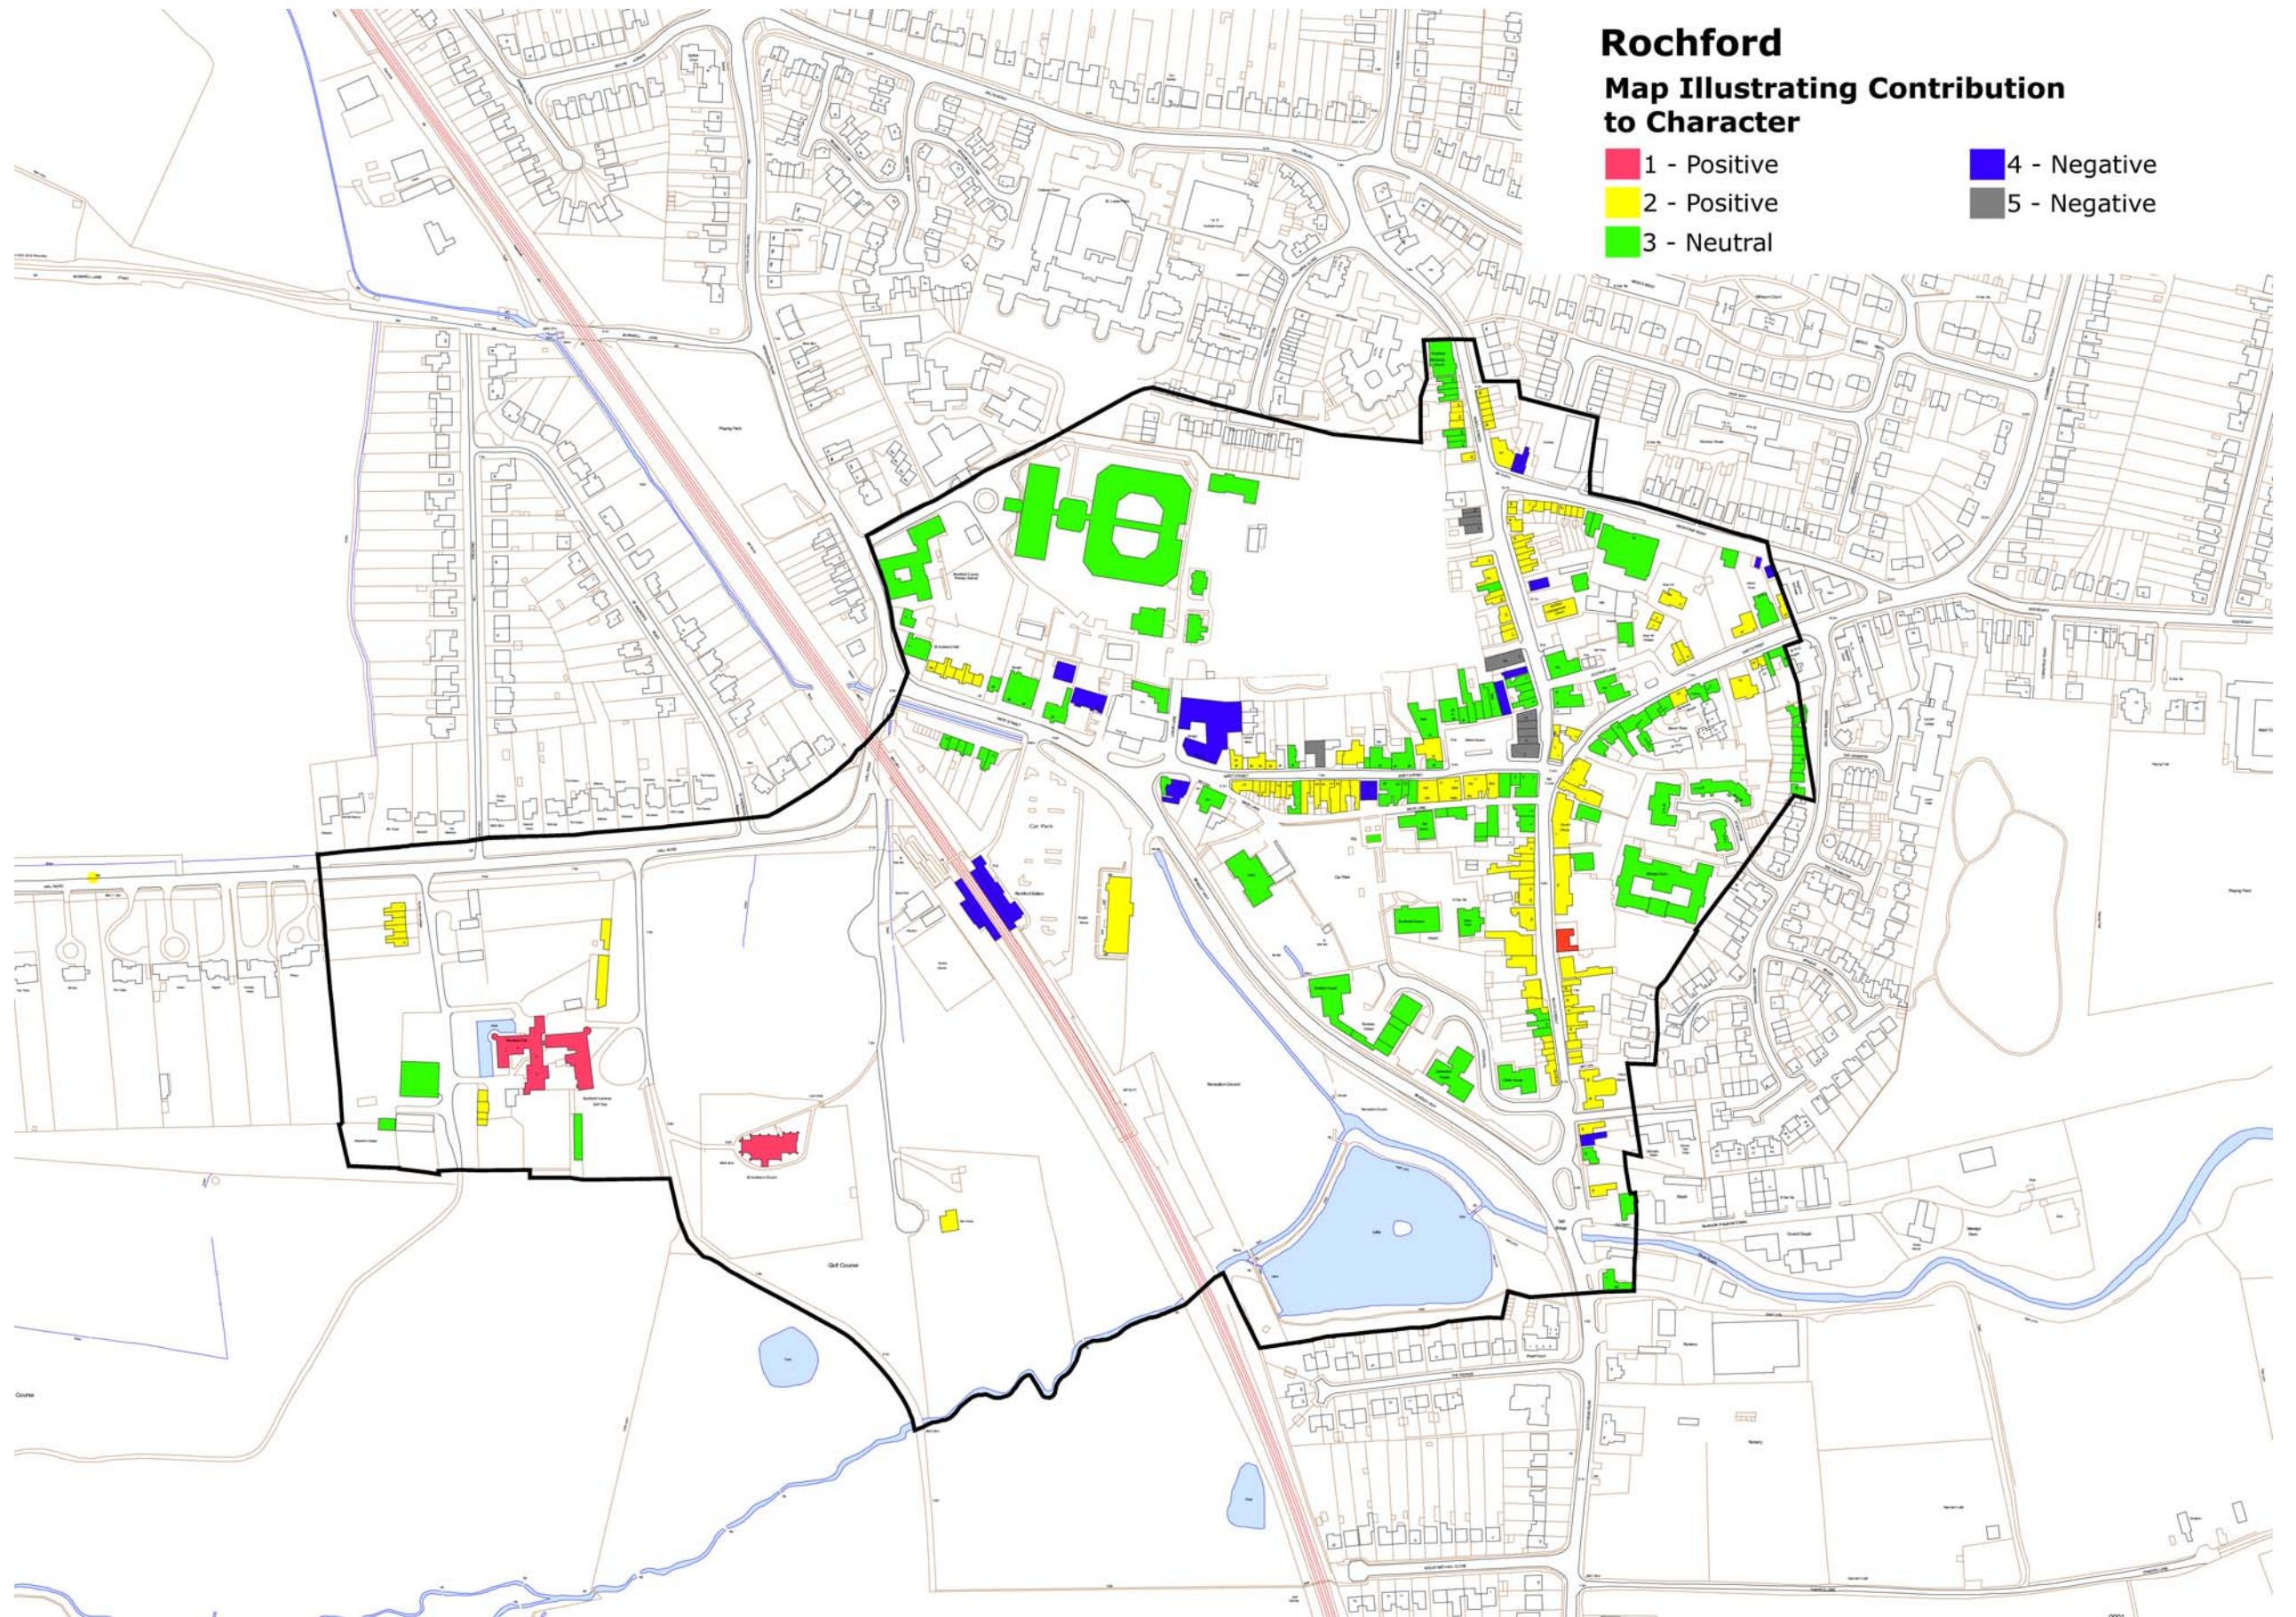
Fig. 59 Map to illustrate the contribution of individual buildings to the conservation area.

- 2.1 A map (*Fig. 59*) has been prepared assessing the contribution made by individual buildings to the appearance and character of the conservation area. Although a subjective process, the map can be a helpful guide in the planning process. Buildings have been graded on a scale of five according to the following criteria:

- Positive, listed buildings or landmark buildings.
- 2.2 Unsympathetic alterations or 'improvements' can have the effect of moving a building down a grade. Similarly, reversal of such alterations could restore its original character and move it up a grade.

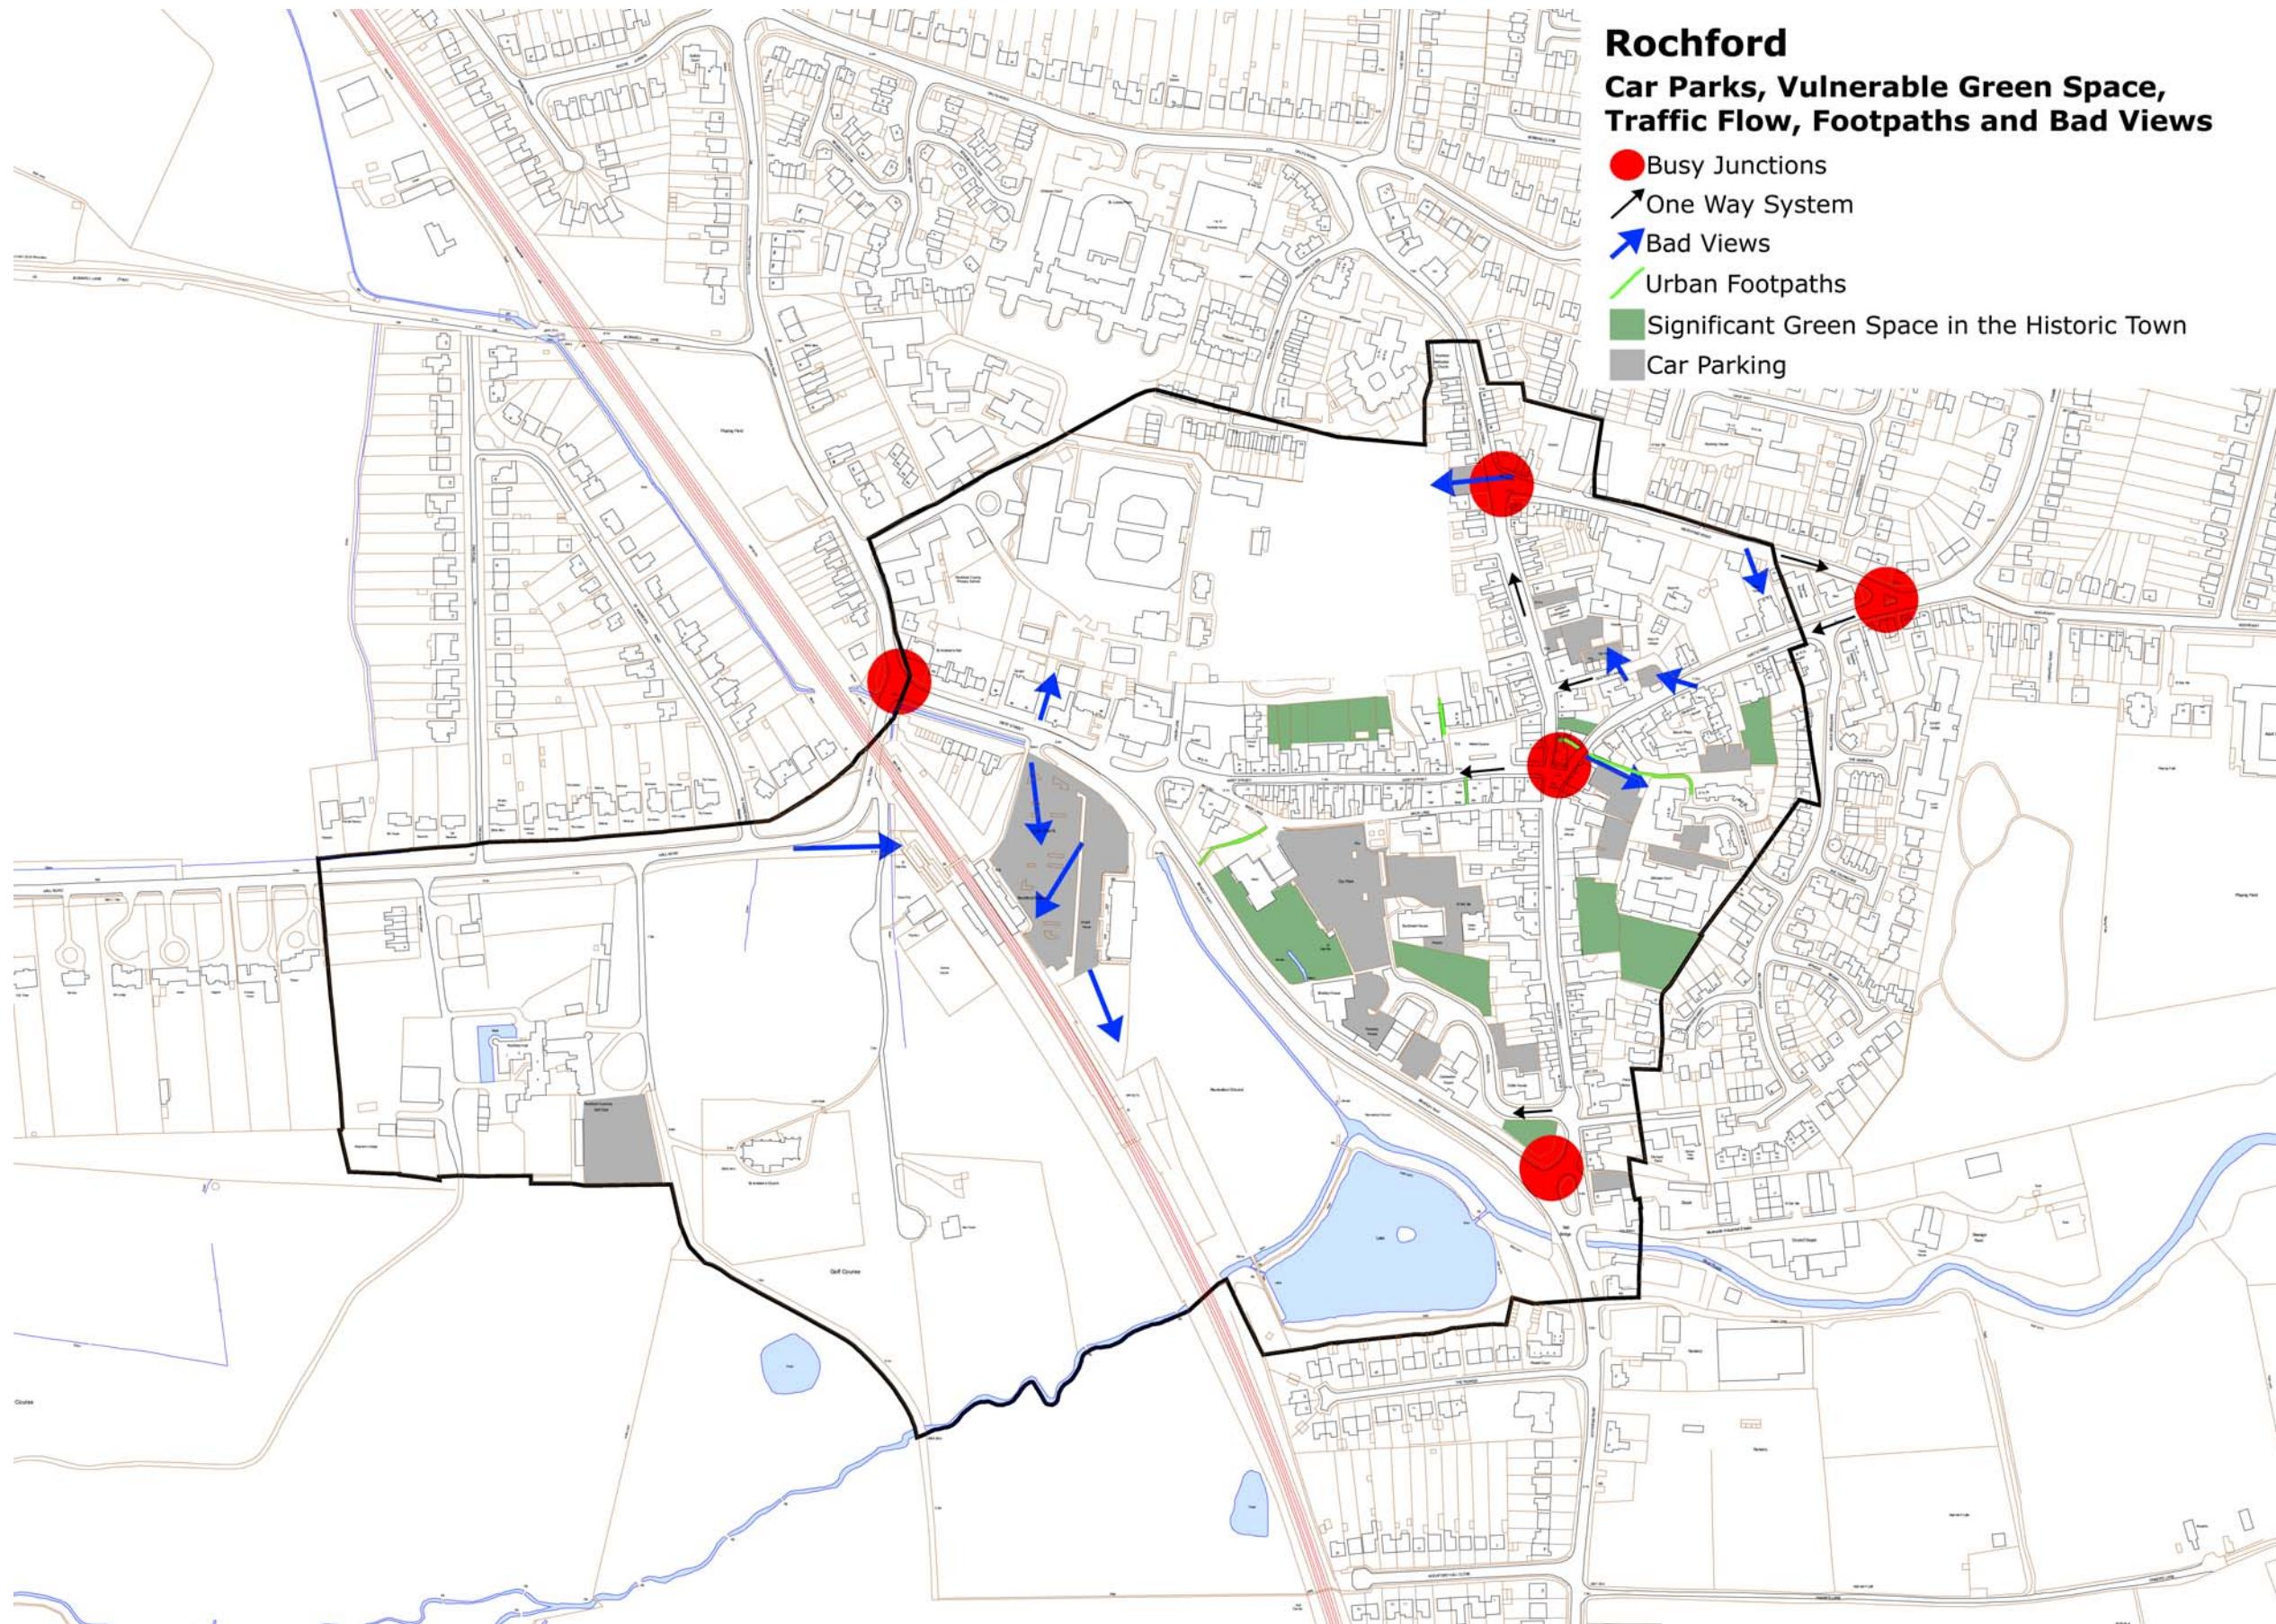
Fig. 60 Map indicating car parks, vulnerable green spaces, traffic flows, footpaths, and bad views in the conservation area.

- 2.3 *Fig. 60* attempts to assess the public realm and open space within the conservation area. It shows bad views; the extent of car parks and parked cars which form negative townscape; green spaces which contribute to the character of the town centre and warrant protection; traffic flows and problems, and footpaths.

- 4.12 The backlands in the Rochford historic town centre are now almost entirely developed for housing, offices or car parking. They have mostly lost their historic relationship to the street frontages and are largely impermeable to them, inasmuch as there are few footpaths leading into them. Important surviving open areas are identified on *Fig. 60*, and should be carefully protected.

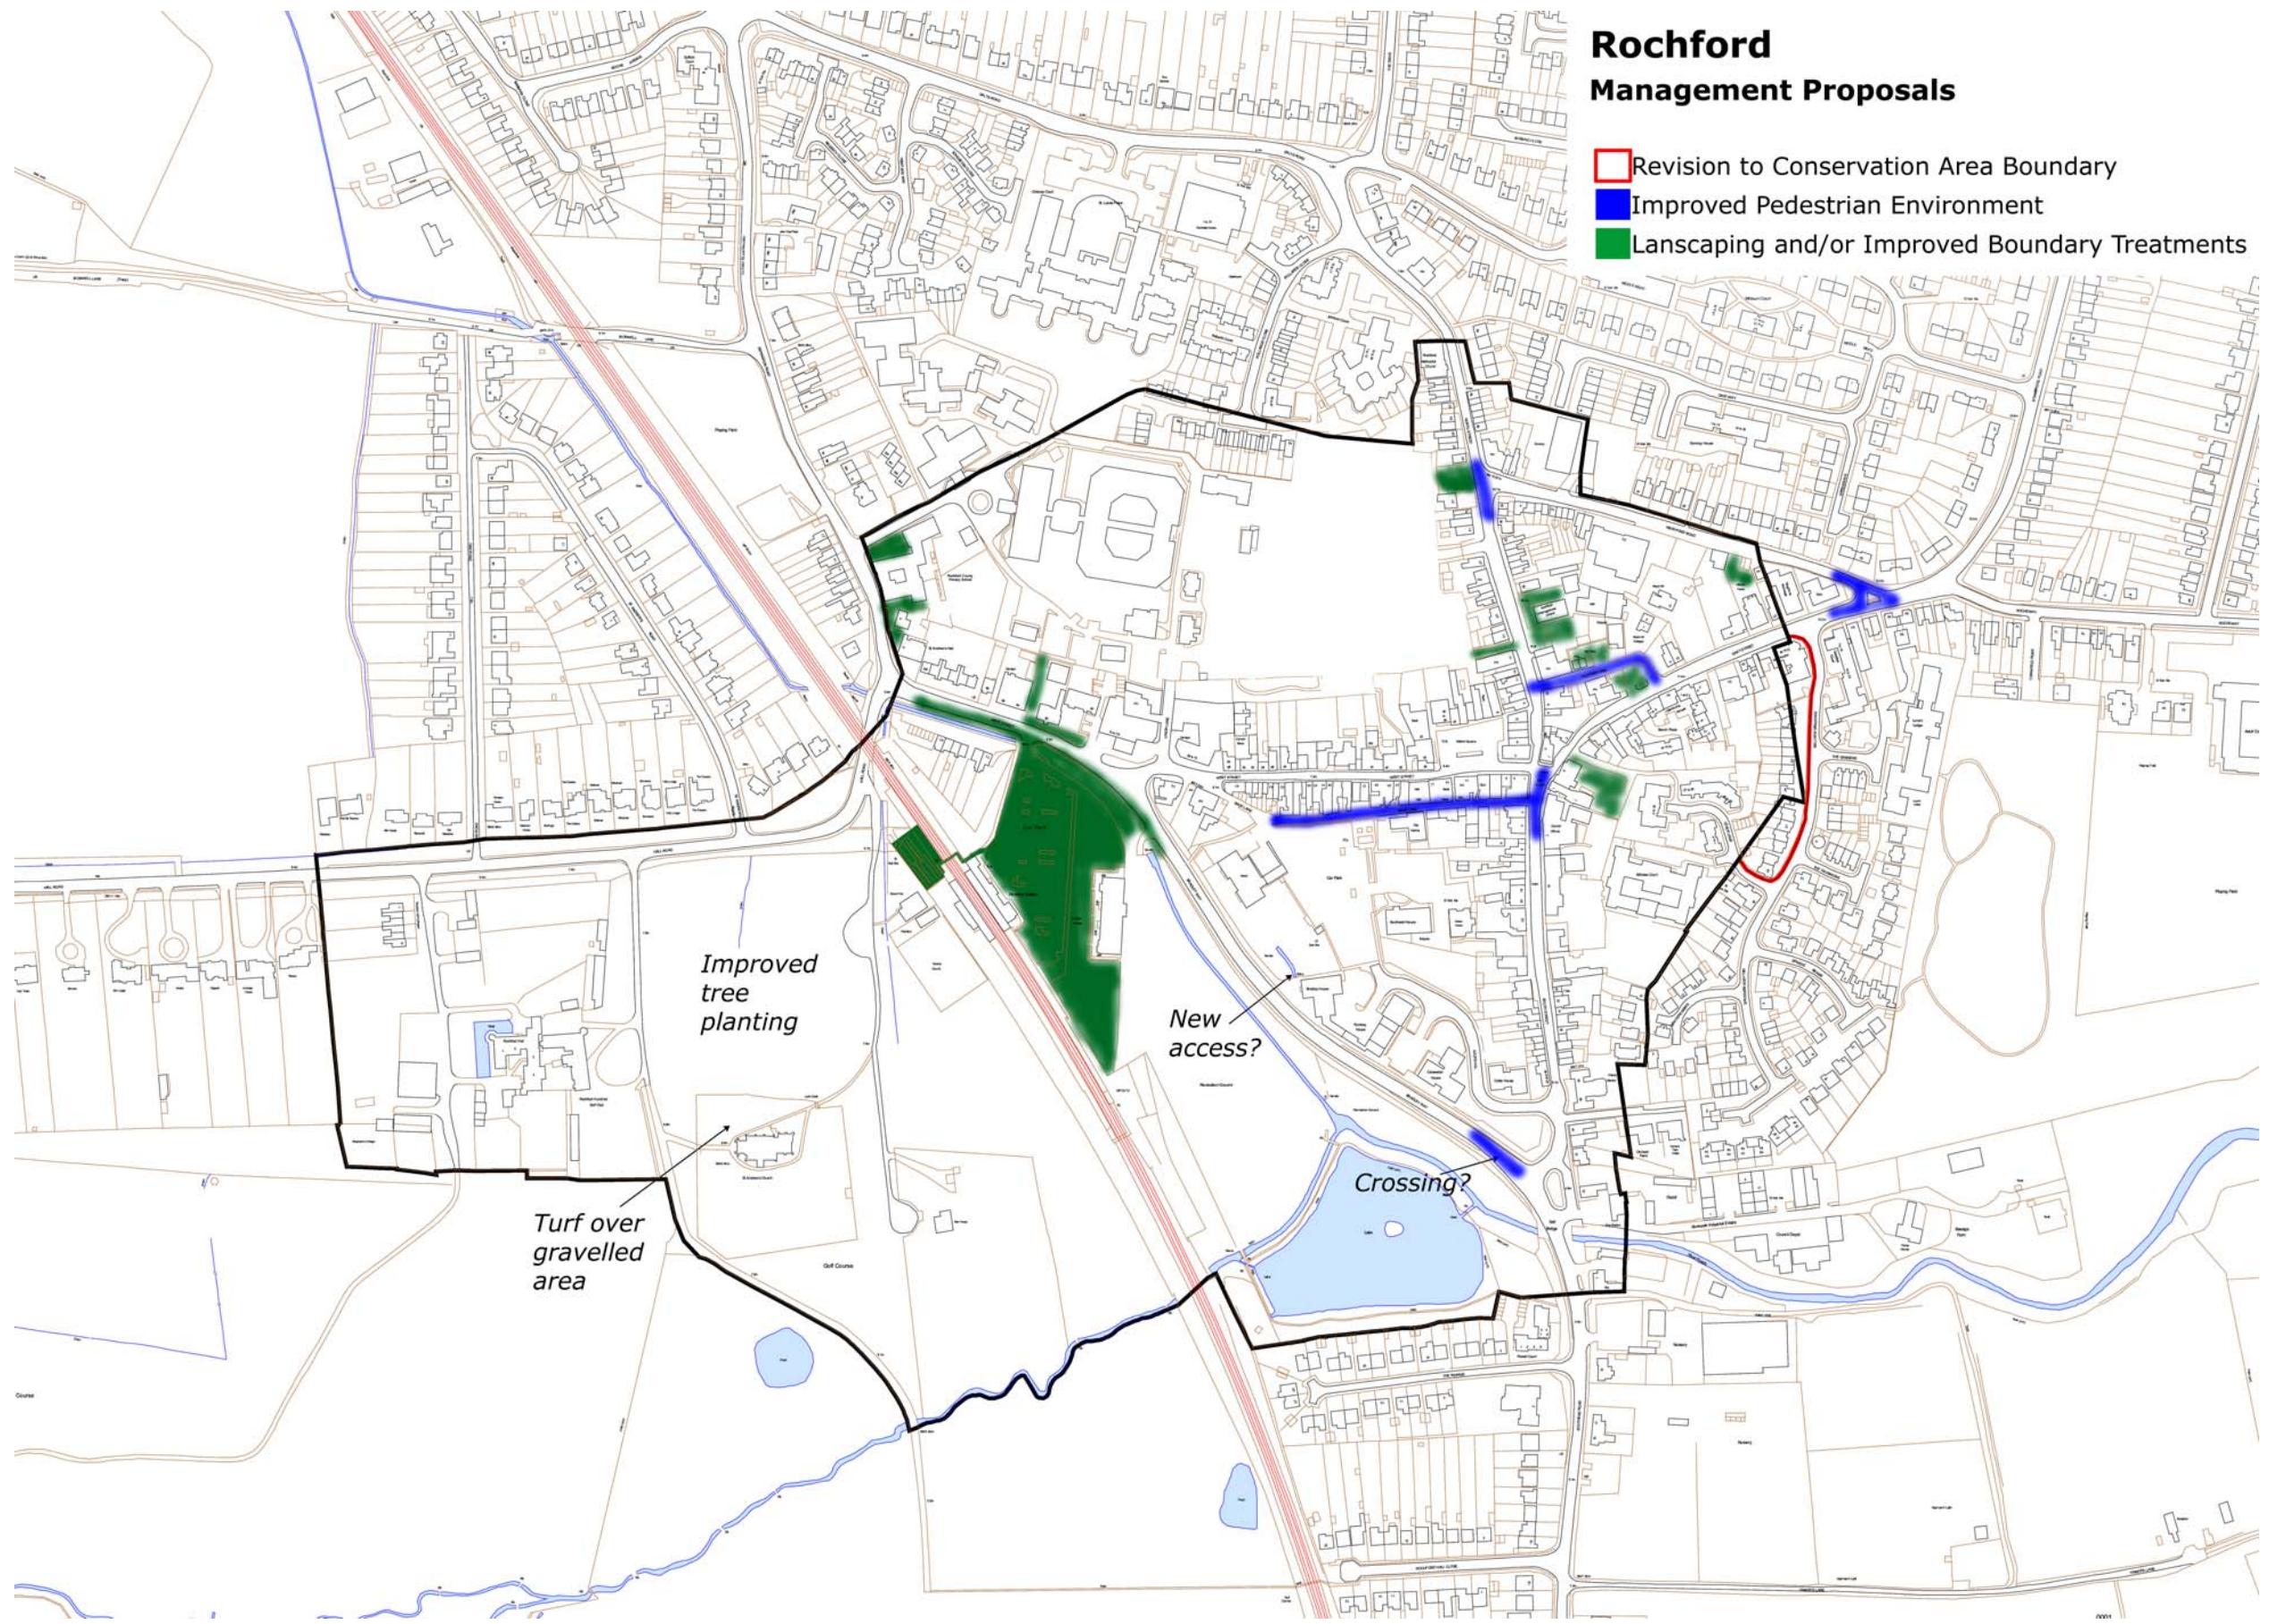
Fig. 61 Map to illustrate management proposals for the conservation area.

4. Management proposals (Fig. 61)

4.19 There are a number of places in the town where improvements could be effected by street enhancement, better signage and boundary treatments, and tree and other planting (*Fig. 61*).

- 4.24 The existing conservation area boundary makes reasonable sense and does not seem in need of alteration, except at its eastern edge where it should be modified to include the office buildings at the junction of East Street and Millview Meadows and then to run down the frontage of the latter (*Fig. 61*). A case could be made for omitting all or part of the hospital site, in particular the healthcare part of it. Since the hospital site is intimately connected with the town centre, occupying its former backlands and influencing views in the area of West and North Street, and since the development is not very far advanced, this is a question that is probably best left for consideration at a later date.
